DDAS Accident Report

Report date: 22/01/2004	Accident number: 6
Accident time: 11:10	Accident Date: 10/11/1997
Where it occurred: Gomley Village, Sharbazar District	Country: Iraq
Primary cause: Field control inadequacy (?)	Secondary cause: Inadequate equipment (?)
Class: Victim inattention	Date of main report: 14/11/1997
ID original source: SB (date nominal)	Name of source: MAG
Organisation: [Name removed]	
Mine/device: Valmara 69 AP Bfrag	Ground condition: rocky, wet
Date record created: 11/01/2004	Date last modified: 11/01/2004
No of victims: 1	No of documents: 2

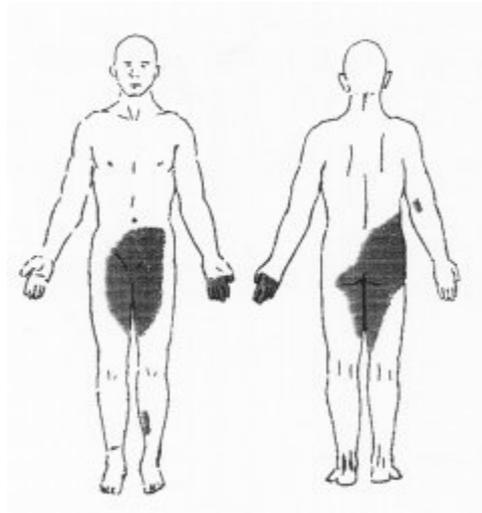
"massive soft tissue injury in the groin with loss of genitals and muscle tissue in both inner thighs; both femoral arteries severed and femur bones fractured. Loss of tissue to right buttock; muscles in the right outer thigh were severed and pelvic bone visible; deep soft tissue damage to the left hand with partial amputation of fingers; soft tissue injury to outer side of right upper arm".

The medic's sketch below shows the extent of the severe injuries.
