DDAS Accident Report

Report date: 22/01/2004	Accident number: 7
Accident time: not recorded	Accident Date: 10/03/1998
Where it occurred: Naghrak Village, Surkhroud District, Nangahar Province	Country: Afghanistan
Primary cause: Field control inadequacy (?)	Secondary cause: Management/control inadequacy (?)
Class: Excavation accident	Date of main report: [No date recorded]
ID original source: none	Name of source: MAPA/UNOCHA
Organisation: [Name removed]	
Mine/device: PMN AP blast	Ground condition: soft, wet
Date record created: 11/01/2004	Date last modified: 11/01/2004
No of victims: 1	No of documents: 2

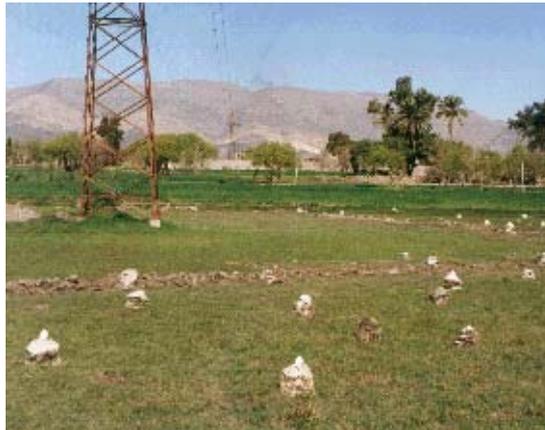
The photograph above shows the ground as grassy and soft/wet with no bamboo or bush. [The researcher photographed the pylon in March shortly after the event and before clearance had been completed]. The type of mine was identified from fragments found at the site.

Having visited the site and spoken with individuals involved, I find the suggestion that the site was overgrown and could not be prodded to be unfounded. The investigators called the site "damp" and it was "marshy" when I visited it. A back-hoe may well have been too heavy to deploy and proven entirely unsuitable.
