DDAS Accident Report

Report date: 22/01/2004	Accident number: 9
Accident time: end of day	Accident Date: 23/11/1997
Where it occurred: Darwishtoolak Village, Pargham District, Kabul Province	Country: Afghanistan
Primary cause: Field control inadequacy (?)	Secondary cause: Management/control inadequacy (?)
Class: Excavation accident	Date of main report: [No date recorded]
ID original source: none	Name of source: MAPA/UNOCHA
Organisation: [Name removed]	
Mine/device: PMN AP blast	Ground condition: hard
Date record created: 11/01/2004	Date last modified: 11/01/2004
No of victims: 1	No of documents: 2

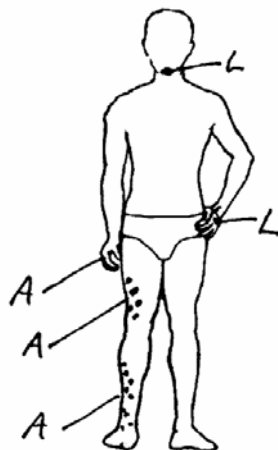
A medic's sketch (reproduced below) showed abrasions on the right thigh and right shin, lacerations on the left hand and a laceration on the chin. No right hand injury was shown [the artist was apparently confused reversing the image in his mind].

The demining group reported the injuries as: right hand polex, index and medianus amputated, other wounds. Left hand lacerated. Right thigh and shin superficial lacerations: chin lacerated: Left eye foreign bodies: "face trauma by helmet".
