# DDAS Accident Report

<b>Report date:</b> 22/01/2004	<b>Accident number:</b> 11
<b>Accident time:</b> 13:14	<b>Accident Date:</b> 27/04/1999
<b>Where it occurred:</b> Kapfudze Village, Mukumbura	<b>Country:</b> Zimbabwe
<b>Primary cause:</b> Management/control inadequacy (?)	<b>Secondary cause:</b> Inadequate training (?)
<b>Class:</b> Handling accident	<b>Date of main report:</b> [No date recorded]
<b>ID original source:</b> none	<b>Name of source:</b> KMS
<b>Organisation:</b> [Name removed]	
<b>Mine/device:</b> R2M2 AP blast	<b>Ground condition:</b> not applicable
<b>Date record created:</b> 11/01/2004	<b>Date last modified:</b> 22/01/2004
<b>No of victims:</b> 2	<b>No of documents:</b> 3

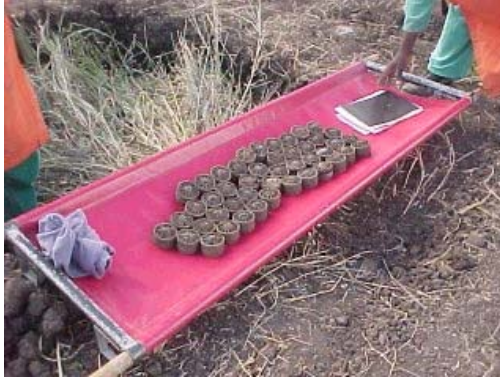
The picture above shows mines brought to the demolition pit in such numbers that a stretcher was used.

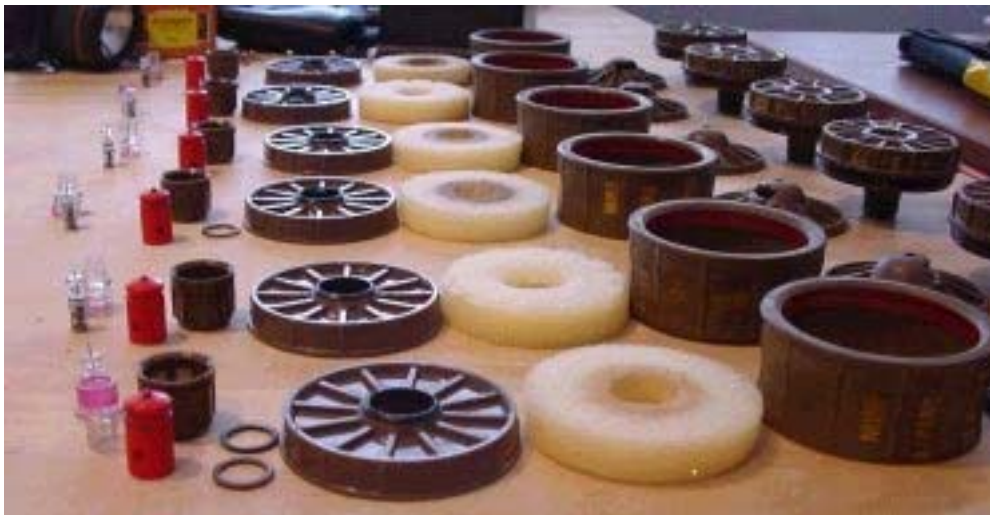
The researcher has dismantled many R2M2 mines in order to make detector test-pieces (some shown below).

In several cases the ball bearing mechanism has jammed and although the balls are lined up with their exit holes, they have not moved sideways to allow the spring-loaded pin to drop. In these cases, they could move at any time – which may explain why the mine went off as the supervisor screwed the booster charge back in. The picture alongside shows the mechanism with the pin just visible above the detonator. The picture below shows the fuze assembly complete with detonator.
