# DDAS Accident Report

<b>Report date:</b> 22/01/2004	<b>Accident number:</b> 19
<b>Accident time:</b> 12:15	<b>Accident Date:</b> 27/03/1998
<b>Where it occurred:</b> Infulene-Komatipoort power line, Moamba District, Maputo Province	<b>Country:</b> Mozambique
<b>Primary cause:</b> Management/control inadequacy (?)	<b>Secondary cause:</b> Inadequate training (?)
<b>Class:</b> Survey accident	<b>Date of main report:</b> 21/04/1998
<b>ID original source:</b> No.76/CND/DED/98	<b>Name of source:</b> CND/IND
<b>Organisation:</b> [Name removed]	
<b>Mine/device:</b> PMN AP blast	<b>Ground condition:</b> rocky, dry
<b>Date record created:</b> 12/01/2004	<b>Date last modified:</b> 12/01/2004
<b>No of victims:</b> 2	<b>No of documents:</b> 3

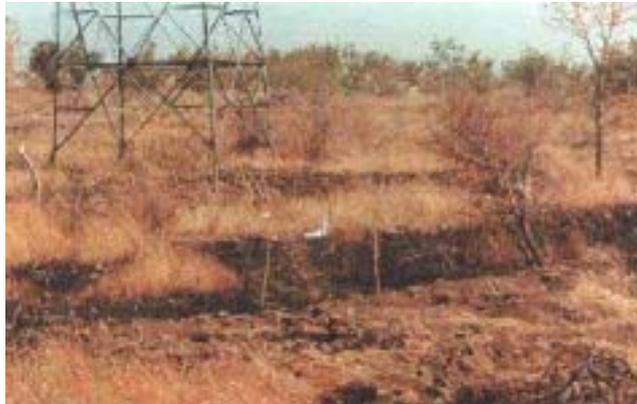
The weather at the time of the accident was cloudy and the ground was dry and stony with burnt vegetation and grass – as shown in the photograph below.

The accident occurred near a high voltage pylon to the south of Moamba town and approximately 22 km from the demining group's camp. The pylon was mined during the armed conflict and a barbed wire fence was put up to prevent the entry of people and animals. Outside this fence were other mines of the PMN, PMN-2 and PMD-6 types.
