DDAS Accident Report

Report date: 11/03/2004	Accident number: 33
Accident time: 09:13	Accident Date: 17/11/1995
Where it occurred: Homoine, Inhambane Province	Country: Mozambique
Primary cause: Field control inadequacy (?)	Secondary cause: Inadequate training (?)
Class: Excavation accident	Date of main report: 27/11/1995
ID original source: ADP-6/ MC/TL	Name of source: CND/IND/ADP
Organisation: [Name removed]	
Mine/device: PMN AP blast	Ground condition: metal fragments
Date record created: 22/01/2004	Date last modified: 22/01/2004
No of victims: 1	No of documents: 1

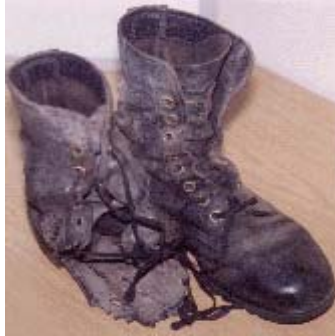
The victim's boots, photographed by the researcher in 1995, are shown here.
