# DDAS Accident Report

| <b>Report date:</b> 19/04/2006 | <b>Accident number:</b> 66 |
| <b>Where it occurred:</b> Quessua, Malange | <b>Country:</b> Angola |
| <b>Class:</b> Missed-mine accident | <b>Date of main report:</b> 18/06/1996 |

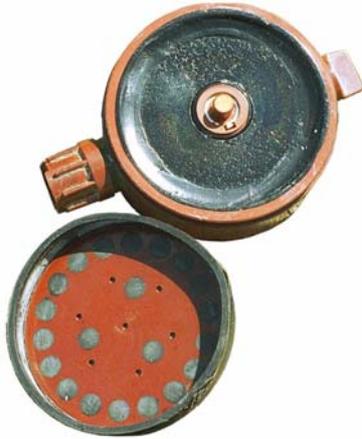
The 240g TNT High Explosive in a PMN is poured into the mine and adheres to the mouldings. This makes it impossible to remove in a useful form. As a result, the disarming of the mine for later use as a demolition charge would require the whole mine to be used as that

The picture shows a PMN with the top removed. The HE charge is coated with a black lacquer.
