DDAS Accident Report

Report date: 19/04/2006	Accident number: 83
Accident time: not recorded	Accident Date: 16/07/1997
Where it occurred: Kichkeen, Shakardarah, Kabul	Country: Afghanistan
Primary cause: Field control inadequacy (?)	Secondary cause: Inadequate equipment (?)
Class: Vegetation removal accident	Date of main report: [No date recorded]
ID original source: none	Name of source: MAPA/UNOCHA
Organisation: [Name removed]	
Mine/device: PMN AP blast	Ground condition: bushes/scrub hard
Date record created: 23/01/2004	Date last modified: 29/02/2004
No of victims: 1	No of documents: 1

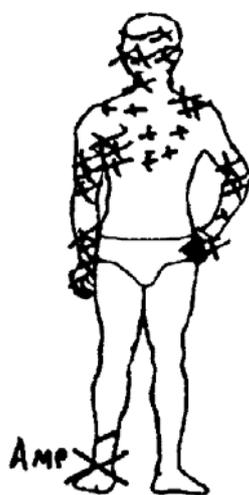
The victim's injuries were summarised as: right leg amputated below knee, internal bleeding to neck, right chest, deep injury to neck, abrasions/frag to head, face, eyes: also as "chest and upper body scattered injuries, including face". No injuries to his lower body, thighs and knees were shown on the sketch (shown below). The victim was evacuated to hospital where he died.

A medic's sketch of his injuries is reproduced below.

The demining group reported that the victim suffered deep lacerated wounds to the right side of his neck and laceration of the carotid artery; amputation of his left leg; lacerated wound right axilla; chest and right hand, and that he died in Kabul hospital due to cardio-respiratory arrest as a result of internal bleeding (arterial damage), shock.

The victim's injuries suggest that the right leg was extended with the upper body over the foot when the mine was initiated, perhaps a position indicative of having "slipped"? The victim's foot may then have caused the fatal neck and chest damage. The face and eye injuries imply that the blast got under the visor, which indicates that it was worn raised.
