# DDAS Accident Report

| <b>Report date:</b> 19/04/2006 | <b>Accident number:</b> 85 |
| <b>Where it occurred:</b> Karti Ghous Uddin,<br>Ward 7, Kabul<br>Province | <b>Country:</b> Afghanistan |
| <b>Class:</b> Excavation accident | <b>Date of main report:</b> [No date recorded] |

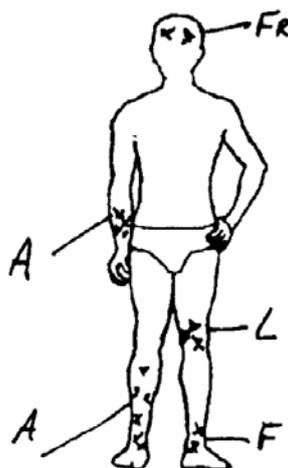
**Medical report**

The medic's sketch of the injuries is reproduced above.

The victim's injuries were summarised as: minor injuries to right hand, left leg below knee, right shoulder, small fragments to eyes.

The victim's eye injuries imply that he was either working without a visor, or with the visor raised. The failure of the investigating team to examine this point was a failing of senior management.
