DDAS Accident Report

Report date: 15/05/2006	Accident number: 104
Accident time: not recorded	Accident Date: 06/04/1997
Where it occurred: Kock Kin Village, Kabul Province	Country: Afghanistan
Primary cause: Field control inadequacy (?)	Secondary cause: Victim inattention (?)
Class: Other	Date of main report: [No date recorded]
ID original source: none	Name of source: MAPA/UNOCHA
Organisation: Name removed	Ground condition: agricultural (abandoned) clay grass/grazing area soft
Mine/device: PMN AP blast	
Date record created: 12/02/2004	Date last modified: 12/02/2004
No of victims: 1	No of documents: 1

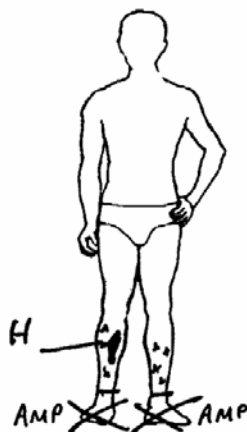
The victim's injuries were summarised as amputation of both legs and injuries to other parts of his body. A medical report recorded that "both legs of the victim have been cut from the tibia", and that there were deep injuries to the tibia on the right leg.

A medic's sketch is reproduced below.
