# DDAS Accident Report

<b>Report date:</b> 12/02/2004	<b>Accident number:</b> 120
<b>Accident time:</b> not recorded	<b>Accident Date:</b> 21/05/1999
<b>Where it occurred:</b> Plowshare minefield, Cordon Sanitaire, Mukumbura,	<b>Country:</b> Zimbabwe
<b>Primary cause:</b> Field control inadequacy (?)	<b>Secondary cause:</b> Inadequate training (?)
<b>Class:</b> Handling accident	<b>Date of main report:</b> [No date recorded]
<b>ID original source:</b> none	<b>Name of source:</b> KMS
<b>Organisation:</b> Name removed	
<b>Mine/device:</b> R2M2 AP blast	<b>Ground condition:</b> not recorded
<b>Date record created:</b> 12/02/2004	<b>Date last modified:</b> 12/02/2004
<b>No of victims:</b> 1	<b>No of documents:</b> 1

The accident occurred in the "Ploughshear" section of a minefield between Zimbabwe and Mozambique. Laid during the 1970s, the extensive minefield was last maintained in the early 1980s. Most mines are R2M2, VS50 and M969 blast mines. The demining group were clearing the area using two-man teams and a one man drill. They routinely "disarmed" all R2M2 mines by removing the booster charge.

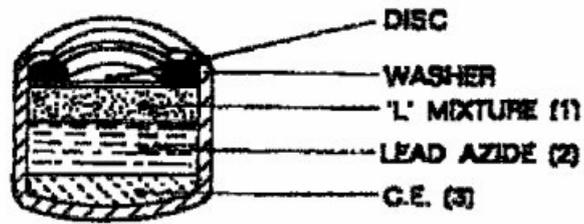
DETONATOR - 6.5 gr LZY

The accident site was examined by the Team Leader who found a charred rock and some plastic fragments and a stone in the ground that "also had charring". The fragments were identified as parts of the "surrounds of the percussion cap" of an R2M2 mine.

The investigator thought that the victim's story of prodding the unknown object with wire was "improbable". He stated that "the most likely cause is that he was holding the object between the thumb and forefinger of the left hand and struck the object with the right hand using the other stone found at the site which he held in an over hand grasp". [This may imply a lack of understanding on the part of the investigator because the detonator is not an "impact" type but a "stab-sensitive" type.]

The primary cause of this accident is listed as "*Field control inadequacy*" because the victim was in breach of SOPs and his actions were not corrected by his supervisor. It seems likely that the victim did not recognise the detonator from the most common mine found at the site. These mines were routinely disarmed with their boosters removed. The detonator would not usually fall out, but may have in this case (alternatively it may have come from a broken mine or been thrown out a pit during demolition by burning). The victim's apparent ignorance of its appearance implies a training lack that would be a management failing. The investigator's ignorance of how it functioned was a further lack of training. The secondary cause is listed as "*Inadequate training*".

It is a further failing that the source of the detonator was not investigated, especially as it may have been thrown out of a burning pit when mines "popped-off" during demolition.

The picture above shows a cut-away drawing of the stab-sensitive detonator,. It is easily initiated by prodding it with any hard object, such as a piece of stick or wire.
