DDAS Accident Report

Report date: 12/02/2004	Accident number: 121
Accident time: 06:27	Accident Date: 10/05/1999
Where it occurred: Cordon Sanitaire,	Country: Zimbabwe
Primary cause: Unavoidable (?)	Secondary cause: Unavoidable (?)
Class: Handling accident	Date of main report: [No date recorded]
ID original source: none	Name of source: KMS
Organisation: Name removed	
Mine/device: R2M2 AP blast	Ground condition: not applicable
Date record created: 12/02/2004	Date last modified: 12/02/2004
No of victims: 1	No of documents: 2

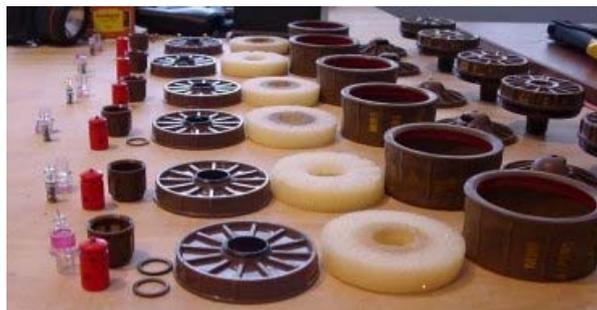
The "crystallisation" explanation given by the demining group does not make immediate sense. The researcher has dismantled many R2M2 mines in order to make detector test-pieces (some shown above).

In several cases the ball bearing mechanism has jammed and although the balls are lined up with their exit holes, they have not moved sideways to allow the spring-loaded pin to drop. In these cases, they could move at any time – which may explain why the mine went off as the supervisor unscrewed the booster charge. The picture alongside shows the mechanism with the pin just visible above the detonator.
