DDAS Accident Report

Report date: 15/05/2006	Accident number: 135
Accident time: not recorded	Accident Date: 10/12/1997
Where it occurred: Alizai Village, Dand District, Kandahar City	Country: Afghanistan
Primary cause: Field control inadequacy (?)	Secondary cause: Inadequate training (?)
Class: Excavation accident	Date of main report: [No date recorded]
ID original source: none	Name of source: MAPA/UNOCHA
Organisation: Name removed	
Mine/device: PMN AP blast	Ground condition: ditch/channel/trench dry/dusty hard
Date record created: 13/02/2004	Date last modified: 13/02/2004
No of victims: 1	No of documents: 2

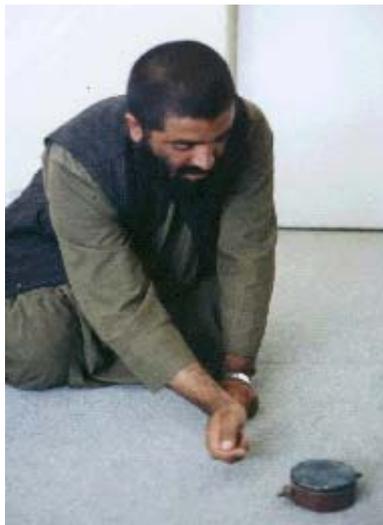
The investigators decided that the victim found a detector reading, marked it, and started to excavate with a pick – contravening a UN MAC directive to stop using a pick for excavation. The mine was identified as a PMN (from "found fragments").

The photograph below shows the victim reproducing the position he was in at the time of the accident (taken by the researcher in July 1998).

The investigators concluded that the deminer did not mark the detector reading properly. Further, the command group ignored procedure and allowed the pick to be used after its use had been prohibited.

He was photographed showing his position when the accident occurred.

The investigators recommended that the pick should not be used to investigate a reading point and that the demining group involved should "strongly advise" all their teams to stop such unsafe practices.
