DDAS Accident Report

Report date: 16/05/2006	Accident number: 145
Accident time: not recorded	Accident Date: 07/10/1997
Where it occurred: Tapi Tajbek, Ward No. 6, Kabul City	Country: Afghanistan
Primary cause: Management/control inadequacy (?)	Secondary cause: Inadequate equipment (?)
Class: Excavation accident	Date of main report: [No date recorded]
ID original source: none	Name of source: MAPA/UNOCHA
Organisation: Name removed	
Mine/device: PMN AP blast	Ground condition: agricultural (abandoned) bushes/scrub hard
Date record created: 13/02/2004	Date last modified: 13/02/2004
No of victims: 1	No of documents: 2

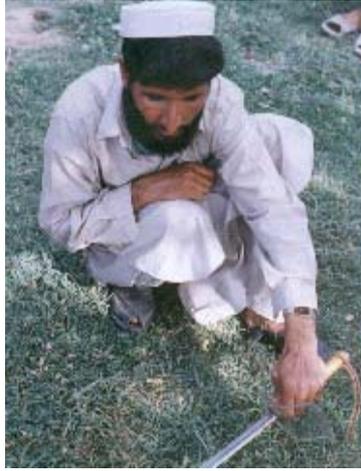
The deminer was interviewed in Kabul on 22nd July 1998 and photographed showing his working position when the accident occurred [he was using a short bayonet].

The victim was working as a deminer again at the time of the interview. He showed his scars – multiple on left leg, left hand and right arm.

He was not wearing a fragmentation vest at the time of the accident because one was not available. He was wearing a visor [not fully down]. The visor was examined and it was marked to 1mm depth, but not punctured.
