DDAS Accident Report

Report date: 17/05/2006	Accident number: 161
Accident time: 08:30	Accident Date: 05/10/1998
Where it occurred: Trapeing Phlong Commune, Ponhea Krek, Kampong Chan Province	Country: Cambodia
Primary cause: Unavoidable (?)	Secondary cause: Inadequate equipment (?)
Class: Excavation accident	Date of main report: 12/10/1998
ID original source: none	Name of source: CMAC
Organisation: Name removed	
Mine/device: M14 AP blast	Ground condition: bushes/scrub dry/dusty electromagnetic hidden root mat
Date record created: 14/02/2004	Date last modified: 29/02/2004
No of victims: 1	No of documents: 2

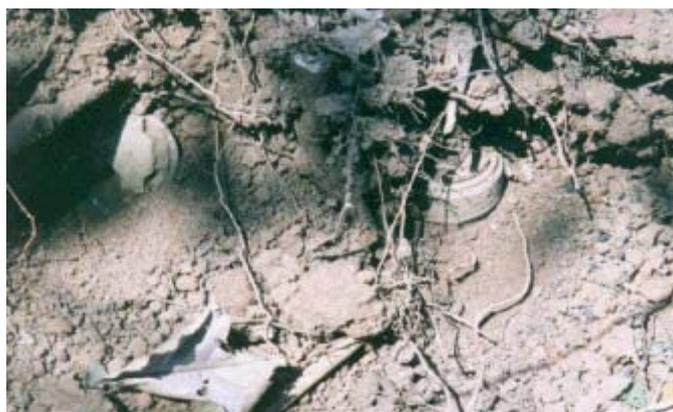
The picture below shows two M14 mines as they were found - one of them at an angle. The picture was taken in the same area as this accident occurred.

Basically this appears to have been an accident where the deminer initiated the mine whilst prodding. His partner had located the item and marked it and both of them were sure that there was a mine present in this location. There was less evidence of roots etc present in the location, although there were some, it does not appear that they were a major contributory factor. It is pure speculation, but it may have been the case that the mine was in the same attitude as the picture I gave you a copy of (from the same site).
