# DDAS Accident Report

<b>Report date:</b> 17/05/2006	<b>Accident number:</b> 162
<b>Accident time:</b> 12:30	<b>Accident Date:</b> 29/09/1998
<b>Where it occurred:</b> Boskhnor, Banan District, Battambang Province	<b>Country:</b> Cambodia
<b>Primary cause:</b> Field control inadequacy (?)	<b>Secondary cause:</b> Field control inadequacy (?)
<b>Class:</b> Excavation accident	<b>Date of main report:</b> 14/10/1998
<b>ID original source:</b> TA/PS/PT	<b>Name of source:</b> CMAC
<b>Organisation:</b> Name removed	
<b>Mine/device:</b> Type 72 AP blast	<b>Ground condition:</b> electromagnetic wet
<b>Date record created:</b> 14/02/2004	<b>Date last modified:</b> 14/02/2004
<b>No of victims:</b> 1	<b>No of documents:</b> 2

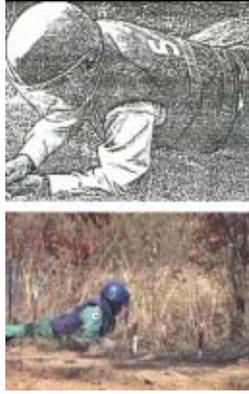
The victim was working in an "unauthorised semi-prone" position. (He claimed to have been lying on a "blue sheet" provided to keep deminers from getting too wet or muddy but there was some doubt over this). A photograph illustrated the victim's supposed position – showing a deminer lying on his side with his torso raised as he leaned on one elbow.

"The unorthodox prodding position used by [the victim] was a direct result of the poor working conditions he was placed in. Although it is not a direct contribution to the accident, it is clear that by using a semi-prone position it must have been difficult to properly investigate detector readings." [Note that the victim was not investigating detector readings if his detector signalled everywhere.]

The picture above (top) was included by the investigators to explain the victim's position. The picture beneath it was taken by the researcher in 1999 - a position observed being used by the group whenever press and observers are present. [Having tried it, it is not possible to lie flatter than this and still have a good view of what you are excavating.]

The internal investigators recommended that the Supervisor should be permanently relieved of his position [he was] and that the minefield manager should be given a written warning. Also that a small garden tool should be issued to aid excavation, and that all deminers should be made aware of their right to refuse to work in conditions that conflicted with SOPs.
