DDAS Accident Report

Report date: 17/05/2006	Accident number: 174
Accident time: 10:55	Accident Date: 23/12/1996
Where it occurred: Ou Andoung, Battambang Province	Country: Cambodia
Primary cause: Field control inadequacy (?)	Secondary cause: Inadequate training (?)
Class: Other	Date of main report: [No date recorded]
ID original source: none	Name of source: CMAC
Organisation: Name removed	
Mine/device: PMN-2 AP blast	Ground condition: grass/grazing area
Date record created: 14/02/2004	Date last modified: 14/02/2004
No of victims: 1	No of documents: 1

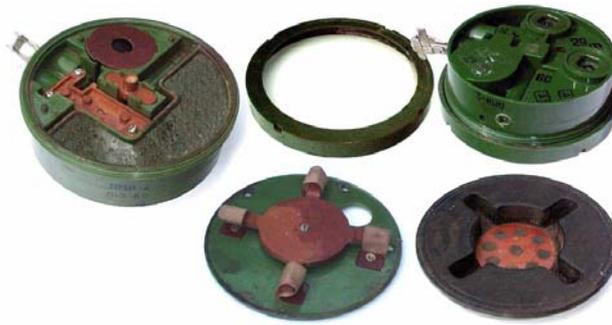
[The PMN-2 booster is in a plastic well accessible from the underside of the mine. It is initiated by a detonator which must also have been in place. This implies that most of the lower half of the mine was in one piece after it had supposedly been destroyed.]

This accident illustrates the dangers involved in destroying/deflagrating mines. The PMN-2 is constructed with its main charge in one half of the body of the mine: placing a charge against the other side is unlikely to cause a sympathetic detonation.

The HE in the PMN-2 is cast into one side of the mine, then it is usually lacquered. It is black in the picture above.

If the mine had been detonated, the "booster" and detonator would have been initiated and no dangerous parts left. Complete deflagration achieves the same end. A plastic explosive

charge is much easier than TNT blocks to place in good contact with the side of the mine and so ensure a shock-wave transfer and a detonation of the mine.
