# DDAS Accident Report

<b>Report date:</b> 18/05/2006	<b>Accident number:</b> 180
<b>Accident time:</b> 10:30	<b>Accident Date:</b> 02/02/1996
<b>Where it occurred:</b> Kaup Prich, Battambang Province	<b>Country:</b> Cambodia
<b>Primary cause:</b> Field control inadequacy (?)	<b>Secondary cause:</b> Inadequate equipment (?)
<b>Class:</b> Missed-mine accident	<b>Date of main report:</b> [No date recorded]
<b>ID original source:</b> none	<b>Name of source:</b> CMAC
<b>Organisation:</b> Name removed	
<b>Mine/device:</b> Type 72 AP blast	<b>Ground condition:</b> not recorded
<b>Date record created:</b> 14/02/2004	<b>Date last modified:</b> 14/02/2004
<b>No of victims:</b> 1	<b>No of documents:</b> 1

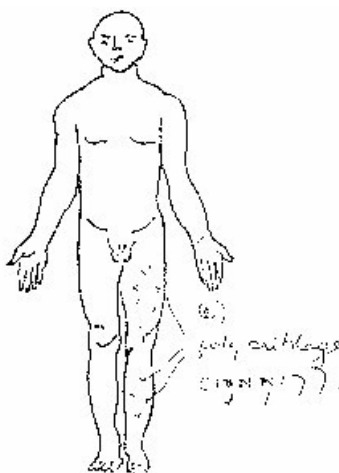
A medical report stated that the victim was unable to use one leg, his right heel was damaged and his left calf was lightly injured.

By 5<sup>th</sup> February amputation of the lower leg was being considered. This was not done. He was discharged from hospital on 27<sup>th</sup> March 1996 when the doctor stated that his right leg injury has left him with an 80% disability with wounds that would take 6-7 months to heal. The left leg injury had already completely recovered. The doctor recommended that the leg injury be treated as a leg loss for compensation purposes.

The sketch below is reproduced from the compensation file.
