DDAS Accident Report

Report date: 15/05/2006	Accident number: 206
Accident time: 11:30	Accident Date: 08/06/1999
Where it occurred: Grebnica, Domaljevac, Posavski (Canton 2)	Country: Bosnia Herzegovina
Primary cause: Management/control inadequacy (?)	Secondary cause: Inadequate training (?)
Class: Demolition accident	Date of main report: 17/06/1999
ID original source: PC/NH/RB/MM	Name of source: BiH MAC
Organisation: Name removed	
Mine/device: PROM-1 AP Bfrag	Ground condition: grass/grazing area metal scrap residential/urban
Date record created: 15/02/2004	Date last modified: 17/03/2004
No of victims: 1	No of documents: 2

ACCIDENT LESSONS LEARNED: JUNE 8th 1999 Team Leader Mine Demolition

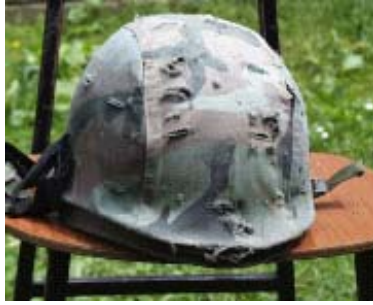
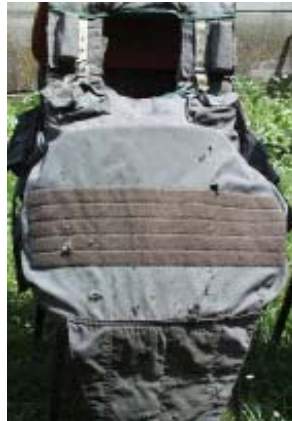
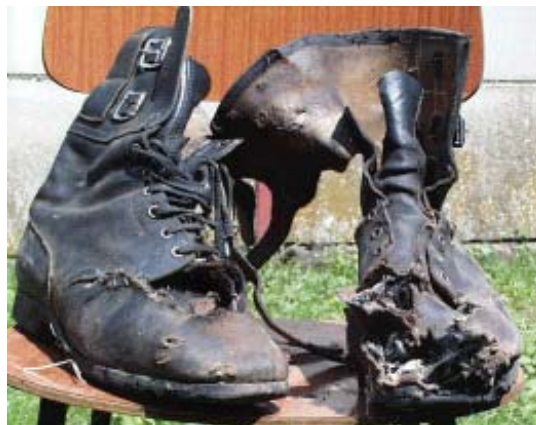
The investigators examined the protective equipment being used. The victim was wearing "an old US military helmet, flak-jacket and military boots". The equipment did not meet the MAC's standard. The helmet had a heavy steel outer and plastic liner. It had no visor. There were three holes on the outside of the helmet where fragments had penetrated. The chin strap was not fastened. 53 fragment holes were counted on the external skin of the frag-jacket. "Eleven fragmentation holes crossed to the level of the chest on the left side". There was no blood on the jacket. Several fragments remained inside it. There were safety "pins" for the PROM attached to the jacket shoulder. [The make of jacket was not identified.]

The victim's boots were torn in the toe area with possible frag holes on the upper. "No trace of blood" was found.

[The pictures show the victim's PPE. The helmet was "holed" and the toe of one boot shredded. The frag jacket took a lot of impacts low down.]

There were many failures of management at the site as identified by the investigators. However, their identification of the protection as inadequate was only well targeted as far as it applied to the failure to provide a visor. As the results of other close-quarter PROM-1 detonations show, a STANAG V50 of 450m/s is unable to provide protection against this threat. The victim would almost certainly still have died if he had been wearing the required protection.

Further recommendations were that work at the site must stop, authorisation for the demining company to operate must be rescinded and its request for authorisation rejected "forthwith". Also that no demining company should be able to continue a demining operation without a visit of MAC inspectors during the first five days. They also recommended that the country MAC should issue a "technical bulletin...on demolition procedures for the PROM-1" and that all protective clothing and equipment for demining must be in accordance with STANAG 2902.

22. The Protective Clothing and Equipment is to be in conformity to International Standards and the former military equipment cannot be agreed as safety for humanitarian demining operations.
