DDAS Accident Report

Report date: 15/05/2006	Accident number: 209
Accident time: 11:15	Accident Date: 15/03/1999
Where it occurred: Grad, Orasca, Una Santon Canton	Country: Bosnia Herzegovina
Primary cause: Management/control inadequacy (?)	Secondary cause: Inadequate training (?)
Class: Survey accident	Date of main report: 17/03/1999
ID original source: WL/RB/HG/JH	Name of source: BiH MAC
Organisation: Name removed	
Mine/device: AP blast (unrecorded)	Ground condition: dry/dusty grass/grazing area sparse trees
Date record created: 15/02/2004	Date last modified: 15/02/2004
No of victims: 1	No of documents: 2

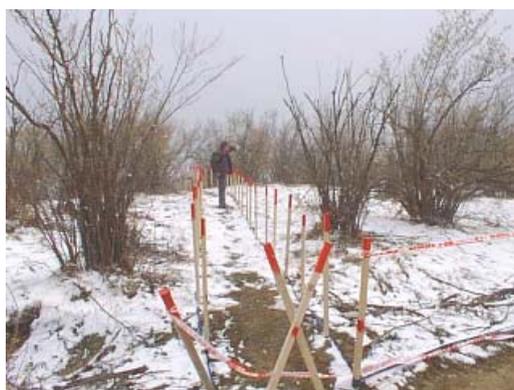
[The picture above was taken during the accident investigation.]

The area where the accident occurred "was described as rough hillside and pastureland" with a sparse covering of small trees and bushes. The grass had been close cropped by grazing animals "and by the activities of the local population". A photograph showed cropped grass and scrubby bush. The ground was dry. The detonation occurred about 15m from an unsurfaced track and about 2 km from the nearest tarred road. There were lines of defensive trenches near the area, the closest being 30m from the accident site. A previous demining operation had cleared 13,000 square metres in the area in 1997 on the opposite side of the track about 100m from the accident site. A mortar and two PMA-2s were found during this clearance.
