# DDAS Accident Report

<b>Report date:</b> 15/05/2006	<b>Accident number:</b> 214
<b>Accident time:</b> 07:15	<b>Accident Date:</b> 10/07/1998
<b>Where it occurred:</b> Aleksa Santic School, West Sarajevo	<b>Country:</b> Bosnia Herzegovina
<b>Primary cause:</b> Inadequate equipment (?)	<b>Secondary cause:</b> Management/control inadequacy (?)
<b>Class:</b> Missed-mine accident	<b>Date of main report:</b> 18/07/1998
<b>ID original source:</b> WL/WM/SB	<b>Name of source:</b> BiH MAC
<b>Organisation:</b> Name removed	
<b>Mine/device:</b> PMA-3 AP blast	<b>Ground condition:</b> bushes/scrub dry/dusty grass/grazing area hard metal fragments
<b>Date record created:</b> 16/02/2004	<b>Date last modified:</b> 16/02/2004
<b>No of victims:</b> 1	<b>No of documents:</b> 2

## REPORT OF BOARD OF INQUIRY INTO ACCIDENT 10 JULY 1998

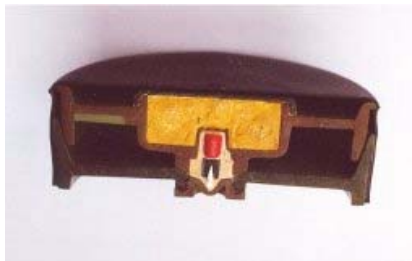
The injuries resulting from stepping on a PMA-3 vary from bruising to traumatic amputations. The picture above shows why this happens. It shows a cut-away section through a PMA-3. The 35g Tetryl is in the top and centre of the mine. The area of pressure-plate surrounding the HE is actually larger than the area of pressure-plate over it. If a victim is fortunate, they step on the pressure plate but the explosive charge is not beneath their foot.
