# DDAS Accident Report

<b>Report date:</b> 15/05/2006	<b>Accident number:</b> 215
<b>Accident time:</b> 09:03	<b>Accident Date:</b> 27/06/1998
<b>Where it occurred:</b> Aleska Santic School, Nedzarici, Sarajevo	<b>Country:</b> Bosnia Herzegovina
<b>Primary cause:</b> Field control inadequacy (?)	<b>Secondary cause:</b> Inadequate equipment (?)
<b>Class:</b> Excavation accident	<b>Date of main report:</b> 29/06/1998
<b>ID original source:</b> WL/FG/WK/SB	<b>Name of source:</b> BiH MAC
<b>Organisation:</b> Name removed	
<b>Mine/device:</b> PMA-3 AP blast	<b>Ground condition:</b> grass/grazing area hard
<b>Date record created:</b> 16/02/2004	<b>Date last modified:</b> 16/02/2004
<b>No of victims:</b> 1	<b>No of documents:</b> 2

### REPORT OF BOARD OF INQUIRY INTO ACCIDENT 27 JUNE 1998

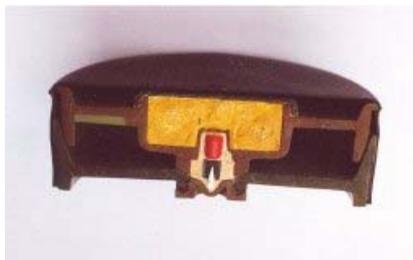
The injuries resulting from stepping on a PMA-3 vary from traumatic amputation to minor bruising. The picture below shows why this happens. It shows a cut-away section through a PMA-3. The 35g Tetryl is in the top and centre of the mine. The area of pressure-plate surrounding the HE is actually larger than the area of pressure-plate over it. If a victim is fortunate, they step on the pressure plate but the explosive charge is not beneath their foot.
