DDAS Accident Report

Report date: 18/05/2006	Accident number: 232
Accident time: not recorded	Accident Date: 23/05/1997
Where it occurred: Travnik	Country: Bosnia Herzegovina
Primary cause: Field control inadequacy (?)	Secondary cause: Field control inadequacy (?)
Class: Missed-mine accident	Date of main report: [No date recorded]
ID original source: Incident no.575	Name of source: other
Organisation: Name removed	
Mine/device: PMA-3 AP blast	Ground condition: ditch/channel/trench woodland
Date record created: 17/02/2004	Date last modified: 01/03/2004
No of victims: 1	No of documents: 1

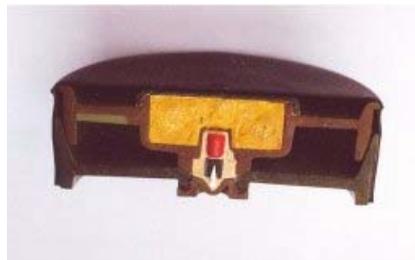
The injuries resulting from stepping on a PMA-3 vary from bruising to traumatic amputations. The picture below shows why this happens. It shows a cut-away section through a PMA-3. The 35g Tetryl is in the top and centre of the mine. The area of pressure-plate surrounding it is actually larger than the area of pressure-plate over it. If a victim is fortunate, they step on the pressure plate but the explosive charge is not beneath their foot.
