DDAS Accident Report

Accident details

Report date: 15/03/2004	Accident number: 255
Accident time: 12:59	Accident Date: 21/09/1999
Where it occurred: Orcusa village, Dragas region, Rapce Onji, Nr Prizren	Country: Kosovo
Primary cause: Unavoidable (?)	Secondary cause: Inadequate equipment (?)
Class: Survey accident	Date of main report: 04/10/1999
ID original source: JR/MD/JF	Name of source: KMACC
Organisation: Name removed	
Mine/device: PMA-3 AP blast	Ground condition: bushes/scrub hard woodland
Date record created: 18/02/2004	Date last modified: 29/02/2004
No of victims: 1	No of documents: 3

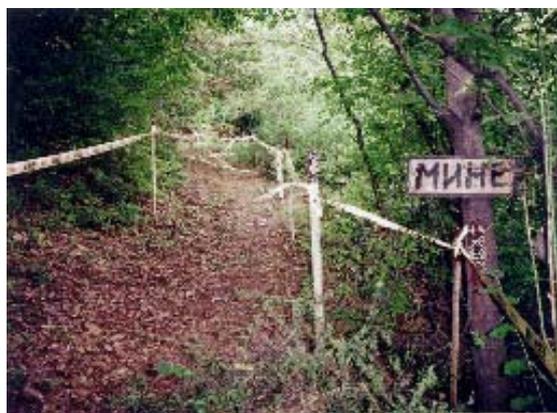
The clearance operation took place along a road/trail used by people from Albania who were stealing parts and items from the abandoned houses on the Kosovo side of the border. The area is a known mined area and is marked by the local population.

A locally made mine sign is shown in the picture of the site below.

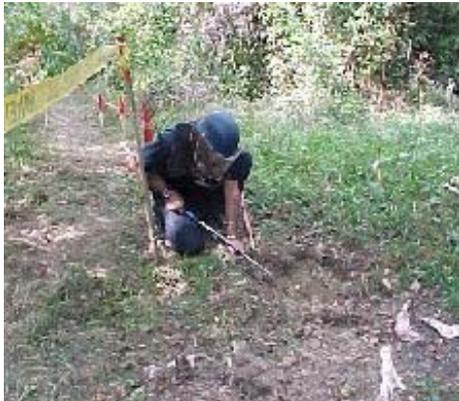
The victim, was clearing a lane past the remains of a dead cow and was already a metre past the cow when the accident occurred. While the victim was sweeping with the mine detector he received a signal on the right 10-cm overlap of the lane he was busy clearing. The ground at the accident site sloped slightly to the right of the lane. The victim started to prod in the area of the signal by using the prodder. When he was prodding on the right of his base stick, he activated an explosive device. This occurred at approximately 13:00.

The picture above shows a reconstruction of the victim's position at the time of the accident.

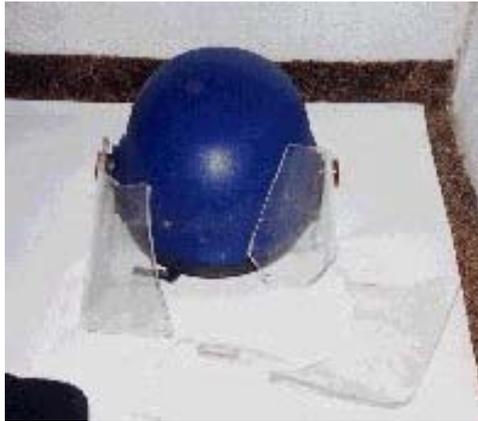
- The deminer is an experienced deminer.
- The deminer was wearing the proper safety equipment.
- The deminer was working in accordance with the SOP's.
- The CASEVAC procedure was followed and done in accordance with SOPs.
- The blast of the explosion deflected between the vest and the visor. The visor shattered.
- The right side of his body absorbed the biggest part of the blast.
- The deminer will keep his eye sight and suffer minor facial injuries.
- The only reliable means of communication on site was the SAT phone.
- The total time to evacuate the injury was 1 hour and 6 minutes.

The visor was entirely unmarked by "soot" or earth in the blast, so it was not directly in the fragment cone associated with the blast, yet it shattered. This leads me to suspect that it was either made from perspex (much cheaper than polycarbonate) or was poorly manufactured so that stresses were locked into it. The clarity of the pieces shown makes the stress theory unlikely. The visor appears to be both thinner than the 5mm standard and very clean. It may have been cleaned before examination to remove marks on the inside (which might have provided evidence that it was raised). The damage to the visor implies that it was a) raised and b) that it may have been made of thin polycarbonate or cheap perspex – both of which fail to meet any approved standard for blast protection. If this was the case, the supply of this equipment would represent a serious management failing. But the cleanliness of the visor raises the possibility that it was not involved in the blast at all. It may have been deliberately broken after the blast to excuse the injuries to the victim's face and eyes.

- The demining group will have to sweep the area to find or confirm the information on the type of mine.
- Refresher procedures on the prodding technique should be given to the de-miners of the group and excavation drills should be developed when the ground is not even.
- The long and heavy version of the prodder used by [the sub-contracted deminers] should be replaced.
- Communication system should be put in place as soon as possible.
- A statement from the injured deminer should be taken as soon as possible.
- Every organisation involved in mine/UXO clearance in Kosovo should be practicing their CASEVAC procedures and to take the constant increasing road traffic on the roads and towns in consideration.
- We are not sure what type of device the deminer initiated and the site therefore will have to be investigated.
