DDAS Accident Report

Report date: 15/03/2004	Accident number: 262
Accident time: 13:25	Accident Date: 30/10/1999
Where it occurred: MNB South, Nr Ljubance	Country: Kosovo
Primary cause: Unavoidable (?)	Secondary cause: Victim inattention (?)
Class: Victim inattention	Date of main report: 11/12/1999
ID original source: KC/MD/JF	Name of source: KMACC
Organisation: Name removed	Ground condition: leaf litter route/path
Mine/device: PMA-2 AP blast	Date last modified: 03/03/2004
Date record created: 18/02/2004	No of documents: 2
No of victims: 1

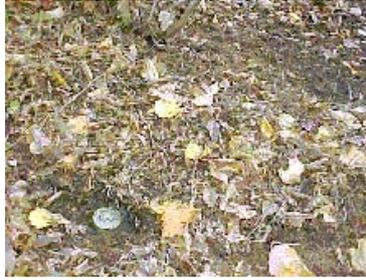
The Accident report included pictures of the accident site which showed the victim's boot and others showing the second PMA-2 less than a meter to the left of the small crater caused by the first mine. (The second mine was found using one of the detectors used at the site.)

The photograph below shows the second mine and the shallow "crater" (top right) of the first mine.

The investigators recommended that "VHF communications" be established "as soon as possible", that the contracted partner in the clearance coalition must clarify with the MAC which group's SOPs were to be used, that refresher courses on drills (especially tripwire) must be carried out, and that the use of the detector whenever possible must be stressed.
