DDAS Accident Report

Report date: 18/05/2006	Accident number: 267
Accident time: 11:08	Accident Date: 22/05/2000
Where it occurred: Nr Kodralija, Peje District, Decani Province	Country: Kosovo
Primary cause: Unavoidable (?)	Secondary cause: Field control inadequacy (?)
Class: Vegetation removal accident	Date of main report: 01/06/2000
ID original source: KC/MD/JF	Name of source: KMACC
Organisation: Name removed	
Mine/device: PMA-3 AP blast	Ground condition: ditch/channel/trench metal scrap route (verge) trees
Date record created: 18/02/2004	Date last modified: 17/03/2004
No of victims: 1	No of documents: 2

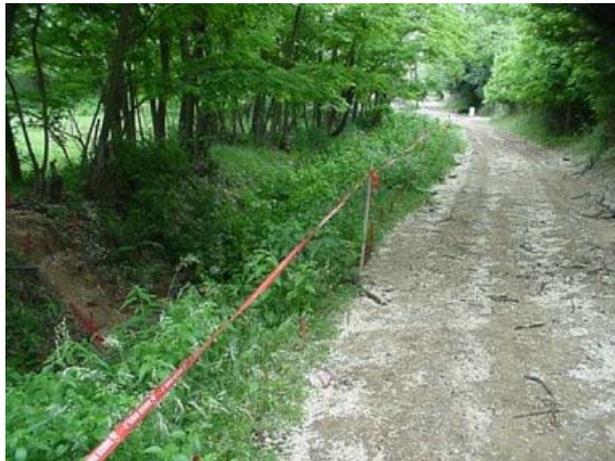
The victim was working in a shady ditch where visibility was poor.

The photograph above shows a dirt road with a line of low trees and a ditch alongside.

The ditch was in deep shadow. The ditch was heavily contaminated with rubbish so a detector was not used.

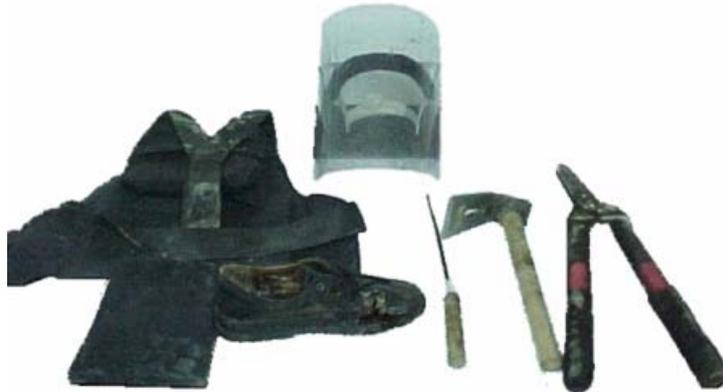
The picture above shows the victim's tools, PPE and the light "trainer" footwear he was wearing. The "trainer" is torn beside the toes but shows very little damage.

There is dust/debris blown into the underside of the shears and bottom edge of the visor which probably indicates the deminer was almost over the top of the blast. The body armour prevented any penetration of fragments to the torso.
