# DDAS Accident Report

<b>Report date:</b> 15/03/2004	<b>Accident number:</b> 273
<b>Accident time:</b> 10:05	<b>Accident Date:</b> 25/08/2000
<b>Where it occurred:</b> Near Restelicia, Gora, MNB South	<b>Country:</b> Kosovo
<b>Primary cause:</b> Management/control inadequacy (?)	<b>Secondary cause:</b> Inadequate training (?)
<b>Class:</b> Handling accident	<b>Date of main report:</b> 17/09/2000
<b>ID original source:</b> KC/MD/JF	<b>Name of source:</b> KMACC
<b>Organisation:</b> Name removed	
<b>Mine/device:</b> Fuze	<b>Ground condition:</b> bushes/scrub grass/grazing area hard
<b>Date record created:</b> 18/02/2004	<b>Date last modified:</b> 18/02/2004
<b>No of victims:</b> 1	<b>No of documents:</b> 1

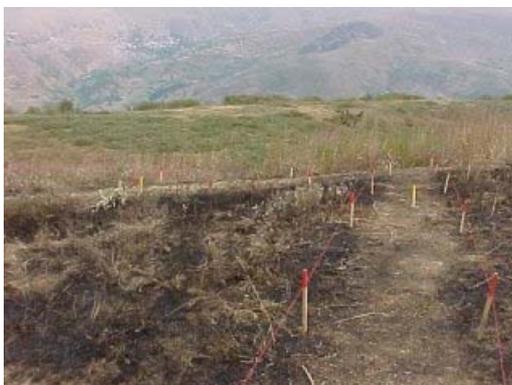
local people having burnt off the vegetation about three weeks previously. The ground was described as "semi-hard" and compacted with "small bush". A photograph showed very little ground cover and large areas of burnt ground. The weather was described as sunny with a temperature of 25C and a light breeze.

The photograph above shows the area being worked on.
