DDAS Accident Report

Report date: 18/05/2006	Accident number: 274
Accident time: 08:12	Accident Date: 23/05/2000
Where it occurred: Nhacondo-Inharrime, Inhambane Province	Country: Mozambique
Primary cause: Field control inadequacy (?)	Secondary cause: Unavoidable (?)
Class: Excavation accident	Date of main report: 26/05/2000
ID original source: none	Name of source: IND/HI
Organisation: Name removed	
Mine/device: GYATA-64 AP blast	Ground condition: grass/grazing area residential/urban sandy trees
Date record created: 18/02/2004	Date last modified: 18/02/2004
No of victims: 1	No of documents: 3

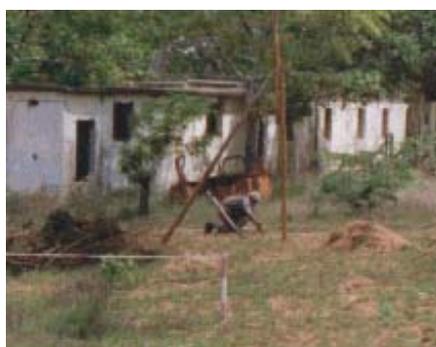
[The picture above shows a deminer excavating a detector reading. This is a "still" from a video made at the site during research in 1999.]

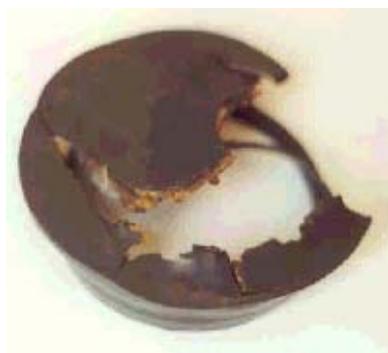
The crater opened by the explosion was about 17cm wide (across) and about 14cm deep.

[The picture above shows the rubber top of the Gyata-64 mine after the accident – clearly illustrating that the mine did not detonate as designed (photographed by the researcher later).]

The position of the mine on its side in the ground could have been the cause of the accident.

During the excavation, the victim did not verify the depth of the mine. In trying to correct this, and due to the mine being at an angle of about 20 degrees, he struck the upper part of the mine and detonated it. Therefore the accident was caused by a bad digging technique and the angled position of the mine.

The demining group's own site investigation and an examination "of the fragments" indicated that the HE in the mine "was possibly in a degraded state". The facts that the trowel "remained intact" and there was no fragment damage to the deminer's "body armour" and visor were taken as evidence supporting the idea that the explosive in the mine had "degraded".

Detection techniques capable of finding minimum metal and mines on their side must be used. Excavation techniques must otherwise be used.

Deminers should be told that mines can be found at depth and on their side. This will help them to know how to deal with such mines, which has been a regular problem. In this regard, it is necessary to test the performance of the detector and its ability to detect mines at their maximum depth. This should also be done for the range of mines expected.

A demonstration on proper digging methods should be made and all Team Commanders told to use these methods.
