DDAS Accident Report

Report date: 19/05/2006	Accident number: 313
Accident time: 10:20	Accident Date: 07/07/2000
Where it occurred: Lurio River Bridge, (Cabo Delgado)	Country: Mozambique
Primary cause: Field control inadequacy (?)	Secondary cause: Inadequate equipment (?)
Class: Excavation accident	Date of main report: 08/07/2000
ID original source: GZ/AVS2001:MZ02	Name of source: HT (field): IND 133
Organisation: Name removed	Ground condition: bridge and surrounds
Mine/device: PMN AP blast	metal scrap route (verge) trees
Date record created: 20/02/2004	Date last modified: 29/02/2004
No of victims: 1	No of documents: 1

Accident report

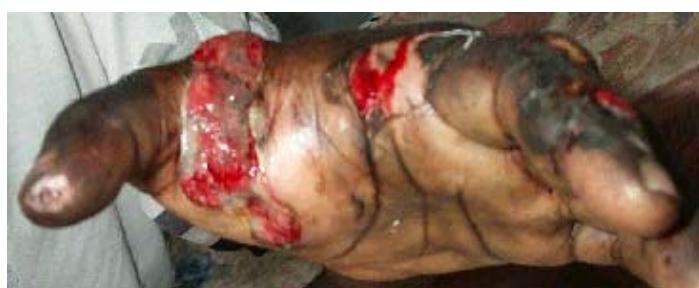
Injuries to the deminer's lower face were caused by the pieces of visor which he had been wearing in the correct manner. The injuries to his left hand were caused by the shattered wooden handle of his enxada which he was using to excavate with. A small point of contention is that the original accident report stated that the casualty had sustained injuries to his right hand rather than those actually to his left. Minor cuts and grazing to his left ankle and upper right arm were caused by secondary fragmentation (soil and stones) from the blast effect of the mine.

The photograph of the victim's hand shown above was made available.

The victim suffered minor cuts and abrasions to the face and damage to his hand, leg and arm.

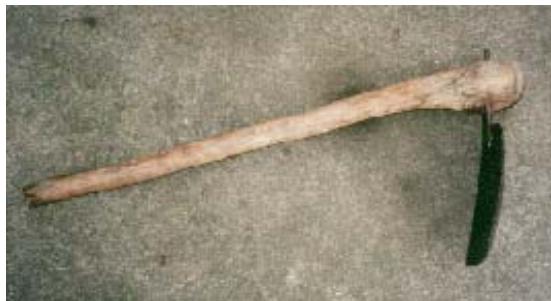
The detector in use was not suitable for use in mineralised soil (as recognized by the decision to use ground-compensating detectors in the internal report) and the quality of the enxada was poor because it broke up in the accident.

A photograph of an enxada is shown above. Locally made, the quality of steel and handle is very variable.

While the use of the tool may be accepted, the quality of the tool being used was clearly inadequate. Hardened steels will crack and shatter in a blast, which appears to have happened in this case. If the blade and the handle were made as one using a medium grade of steel, the tool would be far less likely to shatter and cause injuries – as it apparently did in this case.
