# DDAS Accident Report

| <b>Report date:</b> 15/03/2004 | <b>Accident number:</b> 323 |
| <b>Where it occurred:</b> Rasa Koshare<br>minefield No.358 | <b>Country:</b> Kosovo |

The accident occurred at one of the Rasa Koshare minefield's, Task Dossier Number W02-37, minefield number 358, GR 34T DN 3503 0246 on 30 May 2001 at 12:50.

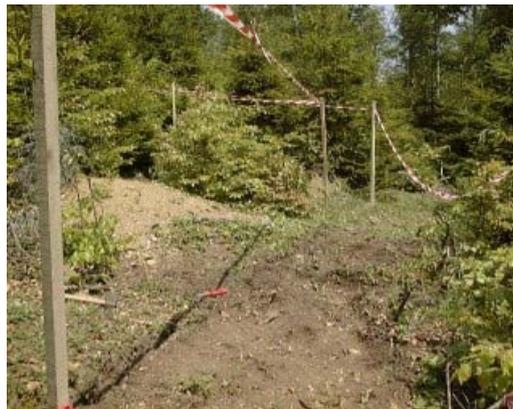
As a consequence of the explosion the hammer was forced into the victim's chest causing bruising, and he then dropped the hammer [the photograph below shows a small hand axe, not a hammer: the red handled knife marks the crater].

The hammer has then fallen outside the marked area. The International Supervisor was standing approximately 2 metres from the victim, and facing in the opposite direction. The International Supervisor did not see the actual explosion or receive any injuries from the blast. Immediately after the explosion he moved to assist the victim and calm him. As the International Supervisor did not realise the victim had received injuries to his foot he attempted to guide him out of the lane and onto the road approximately 35 metres away. The victim was unable to walk and therefore the International Supervisor called to the SL to bring a stretcher to his site. The International Supervisor then called the demining NGO base and reported the accident and requested a helicopter casevac. When the SL arrived both he and the International Supervisor carried the victim out to the road on the stretcher where the medical team was waiting to provide first aid.

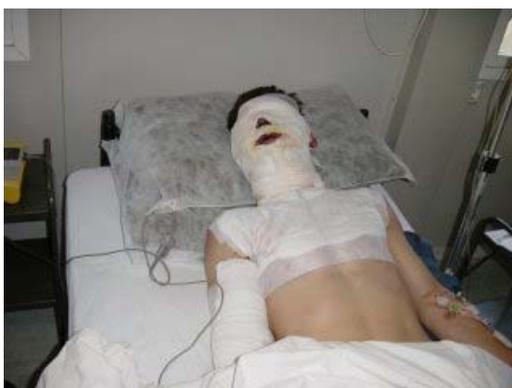
The victim was stabilised and from there he was then taken by ambulance to the HLS located approximately 1.5 km to the south. Further treatment was provided at the HLS whilst awaiting the arrival of the casevac helicopter. The helicopter arrived at 13:47 which was 50 minutes after the request for the helicopter was made and almost 60 minutes after the accident. The photograph below shows the victim in hospital on the day after the accident. The victim was conscious and able to talk whilst awaiting the arrival of the helicopter.
