DDAS Accident Report

Report date: 15/03/2004	Accident number: 324
Accident time: 11:05	Accident Date: 26/04/2001
Where it occurred: Nr Kraljan, MNB West	Country: Kosovo
Primary cause: Field control inadequacy (?)	Secondary cause: Management/control inadequacy (?)
Class: Missed-mine accident	Date of main report: 03/05/2001
ID original source: MF/CC/JF No.002/2001	Name of source: KMACC
Organisation: Name removed	
Mine/device: PMA-3 AP blast	Ground condition: leaf litter soft woodland (light)
Date record created: 20/02/2004	Date last modified: 20/02/2004
No of victims: 1	No of documents: 3

Accident report

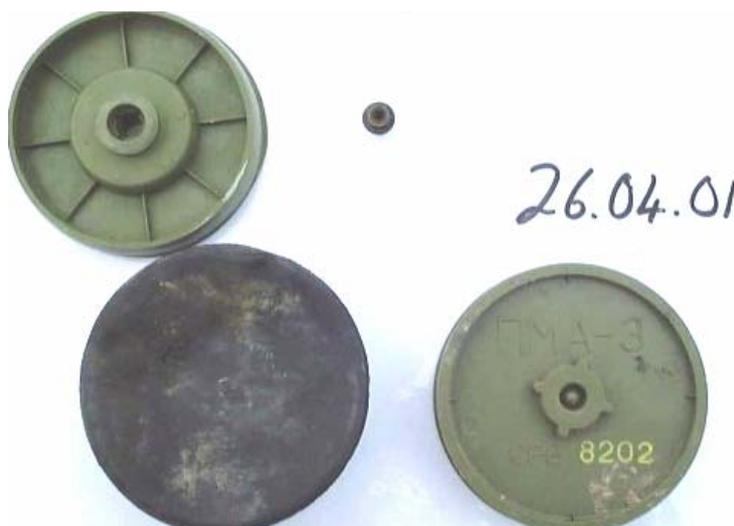
- There was an explosion as opposed to a detonation of the PMA-3 anti-personnel mine when [the demining group] deminer stood on it. The low explosive chemical igniter exploded, but the “flash” was not transferred to the high explosive detonator. Explosions occur in low explosive compounds, whereas a detonation occurs in high explosive compounds.

- Visual inspection of the UPMA-3 fuze showed that the chemical igniter had functioned, but the detonator was still in place. Should the detonator have functioned and the detonating wave been transferred into the main secondary high explosive fill then the resulting injuries to the deminer would have been very serious.

The mine casing was not damaged, and even the brittle plastic of the UPMAH fuze was not broken – as shown in the picture below.
