DDAS Accident Report

Report date: 15/03/2004	Accident number: 326
Accident time: 11:20	Accident Date: 22/05/2001
Where it occurred: Rasa Koshare, Kosovo/Albania border	Country: Kosovo
Primary cause: Field control inadequacy (?)	Secondary cause: Field control inadequacy (?)
Class: Missed-mine accident	Date of main report: 29/05/2001
ID original source: TG/CC/JF No 005/2001	Name of source: KMACC
Organisation: Name removed	
Mine/device: PMA-3 AP blast	Ground condition: leaf litter rocks/stones soft woodland
Date record created: 20/02/2004	Date last modified: 20/02/2004
No of victims: 1	No of documents: 2

4. The accident occurred at one of the Rasa Koshare minefield's, Task Dossier Number W02-37, minefield number 315, GR 34T DN 3509 0156 on 22 May 2001 at 1120 hours.

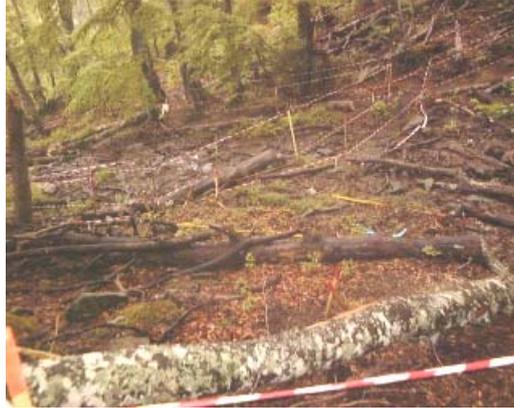
View of accident lane

Lane indicating tape in accordance with present [demining group] operating procedure. There is potential for this tape to be moved into uncleared ground, thereby creating a situation for someone to inadvertently step into this uncleared area.

- There were no witnesses to the accident.
- The clearance lane that [the victim] was working in was approximately 4m long, however according to [the demining group] SOPs there are no clearance lane sticks put in place until a 5m lane has been cleared. This means that the lane indicating tape is not secured except by the start of lane pegs and the base stick. Although it was not a factor in this particular situation, this leaves the tape free to possible movement either side of the actual cleared ground. This has the potential for someone to inadvertently step into an uncleared area.

- [The demining group] amend their SOPs to include the placing of clearance lane sticks (approximately 30 – 50cm in length) every meter when deminers are conducting clearance. This will clearly define the edge of the cleared lane as they progress toward the 5m mark where they then place the longer danger sticks and tape.

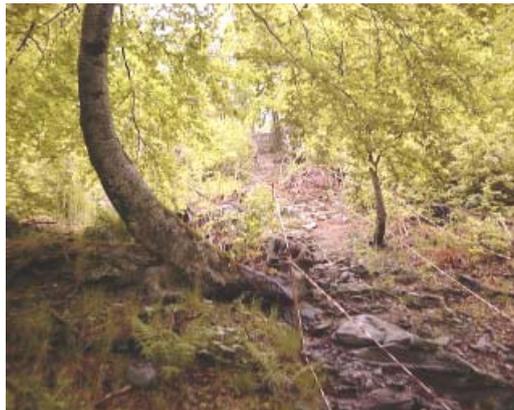
View of steep access to the accident site from the road, also the site of the previous [other demining group] accident.
