DDAS Accident Report

Report date: 15/03/2004	Accident number: 327
Accident time: 10:43	Accident Date: 18/09/2000
Where it occurred: Morina village, MNB West, VJ MF 3501	Country: Kosovo
Primary cause: Field control inadequacy (?)	Secondary cause: Inadequate training (?)
Class: Excavation accident	Date of main report: 18/04/2001
ID original source: MD/EW/LH/JF	Name of source: KMACC
Organisation: Name removed	
Mine/device: PMA-2 AP blast	Ground condition: bushes/scrub grass/grazing area
Date record created: 20/02/2004	Date last modified: 20/02/2004
No of victims: 1	No of documents: 3

Accident report

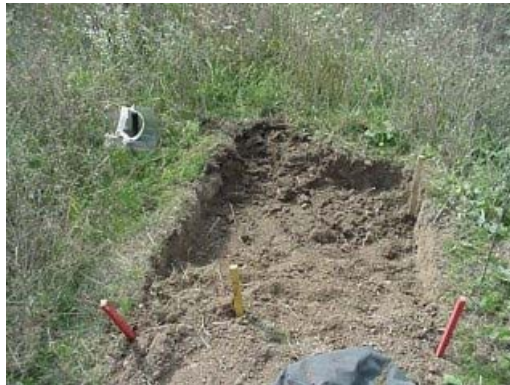
The picture above shows the visor and blast "crater".

There is dust/debris blown into the inside of the visor. Pitting/dust is present towards the base of the visor on the inside. Indicating either the visor has been worn incorrectly, the deminer was almost over the top of the mine when it detonated or the deminer was looking up and away from the mine when it detonated. The first of these options is the most likely, possibly combined with the third.

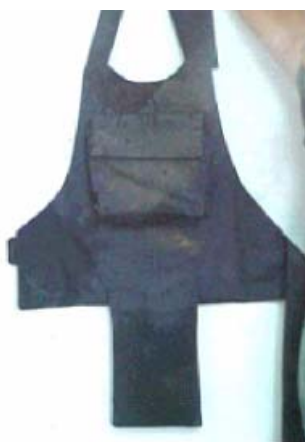
16. At the time of the accident [the Victim] was wearing the proper uniform and personnel protective equipment (PPE) according to the [Demining group] SOPs. However the facial and eyes injuries indicate that the visor was worn incorrectly and that the deminer was almost over the top of the mine when it detonated. According to the [Demining group] the full-face visor they use is designed to withstand the effects of blast and fragmentation mine at close range. The Body Armour used by [Demining group] is a lightweight, one piece, protective vest that is designed to withstand the effects of low velocity ballistic fragmentation at very close ranges. Even if the equipment is worn properly there is always a small gap between the Body Armour and the bottom part of the visor.

[Pictures of the victim are in the Medical report. The picture above shows the Victim's minimal frontal body protection with no collar to interface with the visor.]

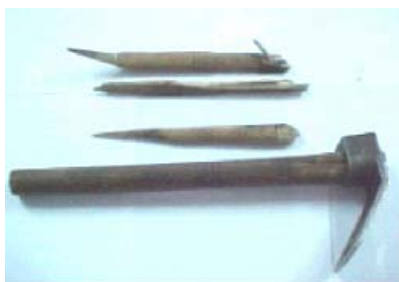
17. The equipment used by [the Victim] at the time of the accident was the appropriate equipment issued by [Demining group] for the sapping drill [metal-detectors were apparently not in use.]. The metal front part of the sapping tool has not been found yet.

The picture above shows the recovered parts of the sapping tool (shards of wood) and a complete tool showing the missing metal head.

A further and significant management failing (that was not known to the investigators) is that this group use a similar wooden handled hoe and sapping technique in other countries and have suffered several similar accidents while doing so. Their management seem not to be aware how frequently their own deminers suffer hand and eye injury in these cases.

Initial impression at the site and from the injuries suffered and damage to equipment, is that the deminer was working in a half-kneeling position excavating with his hand tool in a scraping motion across the face of the lane. The hand tool disintegrated and pieces of the handle have been recovered. The metal head of the tool has not been located at this time.

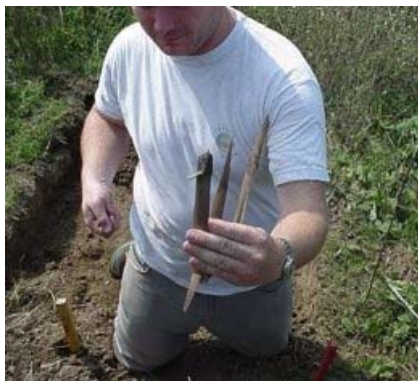
[The picture above was taken during the investigation and shows one of the individuals (the picture is cropped for anonymity) at the accident site with parts of the victim's hoe-handle in his hand. The investigator is on his knees at the end of the lane alongside a marker for a previously located mine. He is not wearing body-armour or visor.]

A final failing of field management was the fact that the initial investigation was conducted with the senior staff involved inspecting the point of initiation while wearing no protective equipment at all. The fact that they photographed this and included it in their report implies that they were not aware that they should have been wearing the PPE.

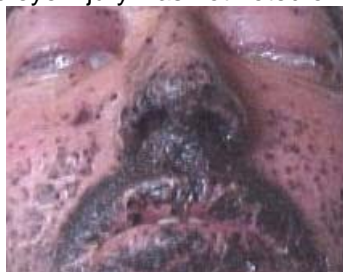
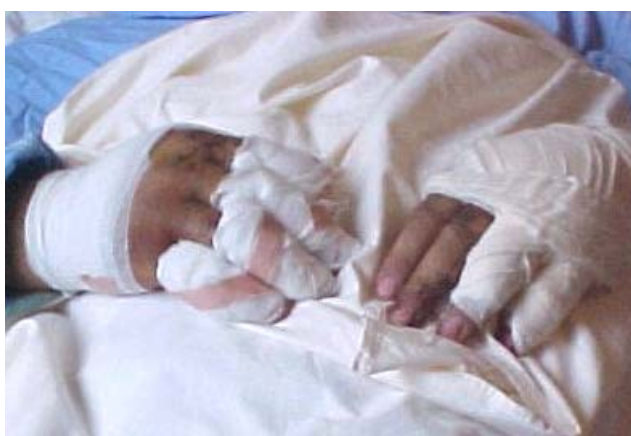
A left shoulder injury was noted by the Section Commander who rescued the Victim from the minefield – see Statements. The Victim's face and hands were photographed in hospital. [It is hard to understand why possible eye injury was not noted on the site.]
