DDAS Accident Report

Accident details

Accident report

Minefield Accident - 18 November 2000

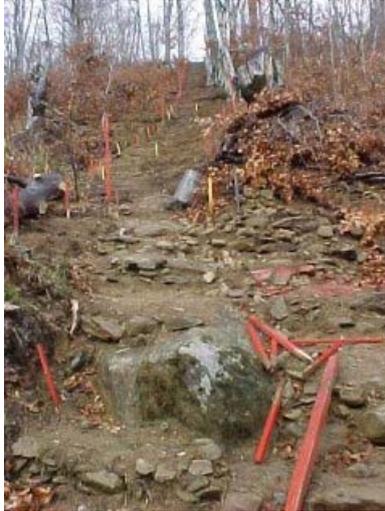
[The picture above shows the accident site. the visor was the victim's. It is some metres from the "adjacent stream".]

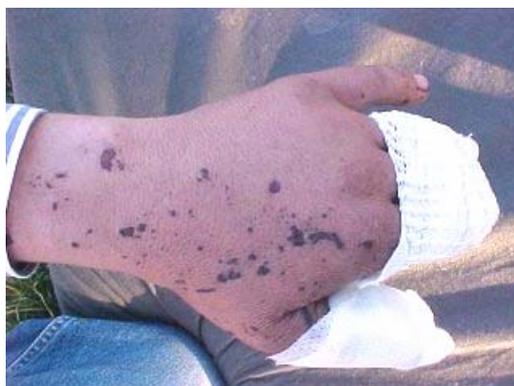
18. At approximately 12h40, the helicopter landed at the HLS. The casualty was loaded and flew directly to the Italian KFOR field hospital. The casualty arrived at the Italian KFOR field hospital at 12h50. The Doctor on duty immediately assessed him. No surgical procedures were required and he was kept for observation overnight and released the next day (see pictures of injuries).

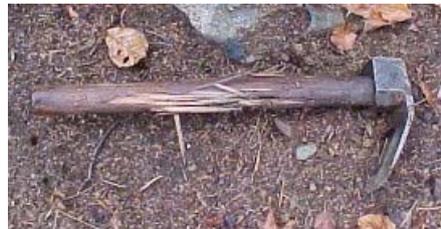
21. There is convincing proof that at the time of the accident, [the Victim] was using the [Demining group] standard sapping tool to drag/remove the vegetation in front of him.

Mine blast damage on the handle of the sapping tool. [What the demining group call a "Trowel" is shown below.]

The secondary cause is listed as "*Inadequate equipment*" because the tool used by the demining group was inappropriate. Euphemistically described as a "trowel" by this group around the world, the tool is a hoe or a side-headed axe. Its wooden handle has frequently featured in injuries for this group.

The centre of the wooden shaft had black/grey scorch marks and was broken at the centre although, not completely severed.

Deminers have only been taught to use the trowel for excavating the ground in a shaving motion working from side to side and not downwards. The trowel should not be used to scrape the surface of the ground or pull vegetation especially as trip wires have been found in the area and some PMA-2 AP mines, which have been found in other areas of Koshare, have a plunger which usually stands above the surface. [The Victim] had been warned by the Team Leader about his work on a number of occasions and this was only his second day in this difficult minefield. Although the minefields he had worked in prior to Koshare had been mixed AP/AT, they had been mapped accurately (Serb records) and as well as being able to pretty much guarantee where the mines were laid, the terrain was far less challenging. Koshare is punishing and there is no room for errors and therefore speed of clearance has to be balanced with cautiousness. He was working carelessly and unsafe and has been extremely lucky to escape with only minor injuries.

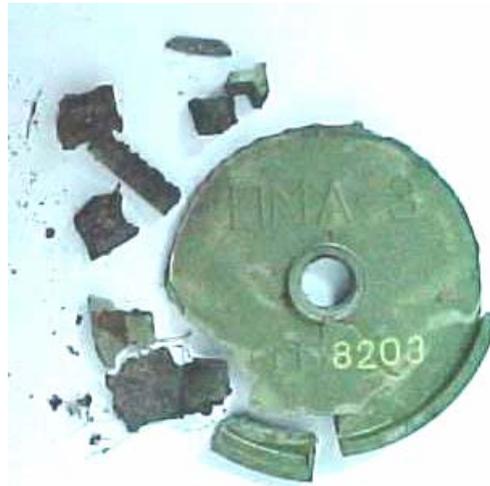
Large parts of the mine's plastic case were recovered and are pictured below. The presence of most of the base implies that it was in the ground and so the mine was not upside-down (as the internal investigator speculated – see Related papers).
