DDAS Accident Report

Report date: 19/05/2006	Accident number: 340
Accident time: 10:15	Accident Date: 09/11/2000
Where it occurred: Nr. Zavala Village, Ravno Municipality	Country: Bosnia Herzegovina
Primary cause: Field control inadequacy (?)	Secondary cause: Inadequate equipment (?)
Class: Vegetation removal accident	Date of main report: 22/11/2000
ID original source: AS/AS/PS/SD	Name of source: BiH MAC
Organisation: Name removed	
Mine/device: PROM-1 AP Bfrag	Ground condition: agricultural (abandoned) bushes/scrub grass/grazing area metal fragments rocks/stones trees
Date record created: 21/02/2004	Date last modified: 21/02/2004
No of victims: 1	No of documents: 1

The following is the MAC's Accident report, edited for anonymity.

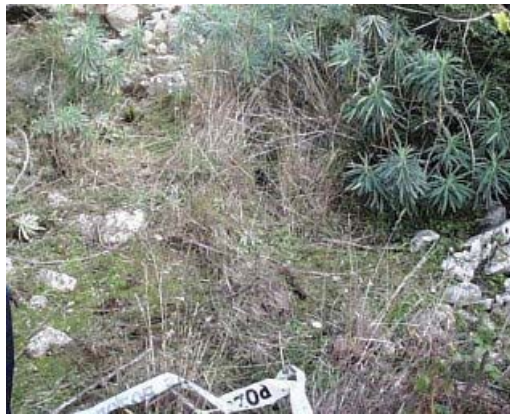
The flat part of the field is suitable for both agriculture and growing grass. Due to long period of its being non-inhabited, grass and thin trees grown over it. There is about 50% of the task where the mild meadow turns to steep rocky area where there is lot less grass and much more thick bushes of even 2-3 metres height. There is a small track leading from the west side of the task, from the railroad track and between the rocky areas. Due to some soil layers on it, this track is grown in grass between the bushes. Due to drought usual during the year, the thick bushes and grass were dry, while new grass grew after a few autumn rains.

[The picture above shows the accident site.]

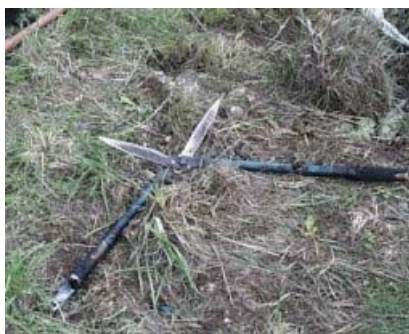
[The picture above shows the long-handled shears in use. Their long handles invite the user to cut beyond the area checked.]

The position of the deceased deminer was in crouching position in the moment of cutting the vegetation. This can be concluded according from the type of injuries of the deceased and the statement of deminer No 2. The blown fist and damages on the shears used, with the damage angle that matches the height of explosion (70-80cm above the ground level), this all proves that the mine was activated by uncontrolled use of the shears for cutting vegetation.

The tools for controlled removal of vegetation were not suitable (instead of smaller shears for cutting grass, garden shears were used for both bushes and grass. The fact is that when cutting bushes we can easily see the level of the ground while conducting removal.

2. The vegetation cutting tools used in the working lane in front of the base stick should be adapted to the vegetation, cutting with control, in order to locate even a surface laid mine, protruding fuse or an UXO.
