# DDAS Accident Report

| <b>Report date:</b> 19/05/2006 | <b>Accident number:</b> 343 |
| <b>Where it occurred:</b> Sudici region, Rogatica Municipality | <b>Country:</b> Bosnia Herzegovina |
| <b>Mine/device:</b> PROM-1 AP Bfrag | <b>Ground condition:</b> metal fragments<br>route/path |

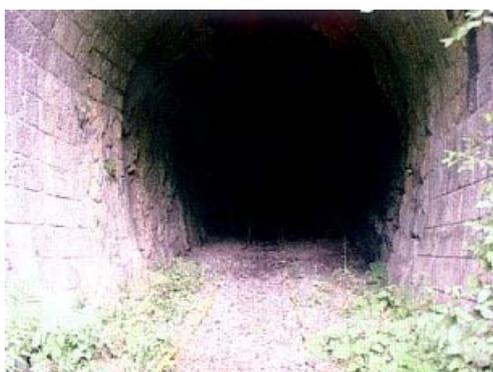
[The picture above shows the tunnel where the accident occurred.]

Explosive device that caused the accident was a PROM-1 mine whose plate was found in the crater made where it detonated, at 25 cm depth from the ground level and 50 cm from the right wall of the tunnel. While investigating the crater on August 23rd 2000 (victims were already taken out), Board of Inquiry requested that Dobož "B" team, who cleared and marked the spot, should clear another working lane by the right side of the tunnel wall in the direction of the crater, which was to be 1.5 metres long towards the crater and another metre further, towards the crater of the mine that killed the fishermen. At about 30 cm from the crater Board of Inquiry found a PMA-2 that was absolutely covered by gravel. The distance of the crater made where the mine detonated is approximately 2.5 metres from the right side, in the direction of tunnel's length. According to Board of Inquiry opinion, the crater of the mine that caused demining accident was right underneath the back of the late fisherman Radomir Lucić, as well as the PMA-2 mine which was found during the investigation.

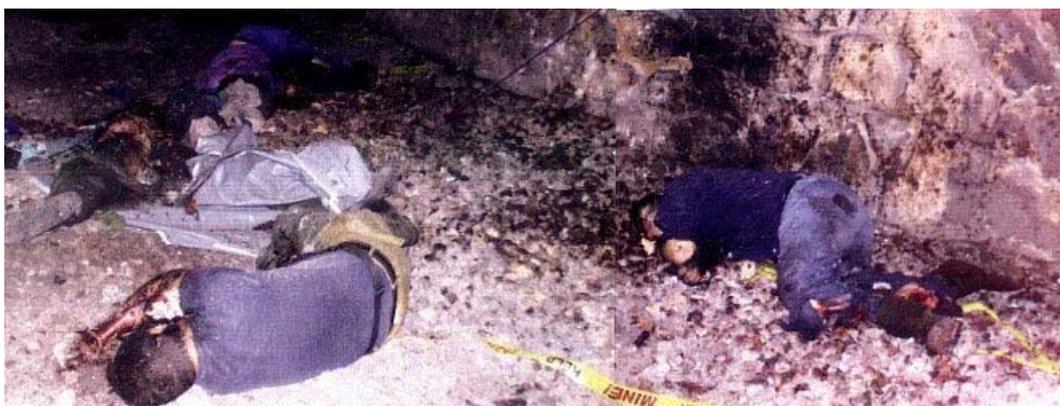
[The picture shows the Victims photographed the next day.]

During the entrance to the cleared part of the mined area and in order to take photographs of the second fisherman and to take further actions on his taking out that actually led to the accident, the killed and the injured wore no personal protective equipment.

The obligatory personal protective equipment was not worn within the mined area neither by the team leader as the lowest level of supervision, nor by the regular supervisor and the manager on behalf of the [Demining group]. This represents all but discipline on site, which can have a very negative impact on demining personnel who in such case were not able to provide any help to the killed and a severely injured person.

The fact that the Victim’s corpses were only checked by a deminer for signs of life is the reason why *“inadequate medical provision”* is listed in the notes. The photographs of the dead (others are in the file) do not show obviously fatal injuries – although there also no indication that the victims had moved after the detonation. However, if it was safe for a deminer to check for signs of life, it should also have been safe for a medic to do so.
