DDAS Accident Report

Accident details

Report date: 19/05/2006	Accident number: 344
Accident time: 13:00	Accident Date: 26/06/2000
Where it occurred: Jorgici-Vrela, Teslic municipality, Republic of Srpska	Country: Bosnia Herzegovina
Primary cause: Management/control inadequacy (?)	Secondary cause: Inadequate training (?)
Class: Excavation accident (survey)	Date of main report: 04/07/2000
ID original source: RB/AA/PJ/SP/EB	Name of source: BiH MAC
Organisation: Name removed	
Mine/device: TMM-1 AT blast	Ground condition: ditch/channel/trench metal scrap soft
Date record created: 21/02/2004	Date last modified: 21/02/2004
No of victims: 2	No of documents: 2

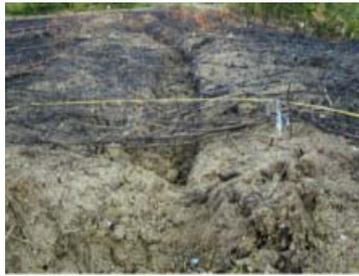
[The picture above shows the trench where the accident occurred – and illustrates how the area was burned off but the undergrowth not cleared away.]

16. Area where accident occurred is metal contaminated with pots, wire, metal tapes, pieces of iron and lots of dispersed burnt vegetation. Final internal control has not conducted its job at this area properly.

57. The area on the very top of the hill (around the accident site) is done quite badly. There is a lot of metal on the surface (metal is to be collected into metal collecting pit), trees in the ruined bunker was not moved, nor in the trenches. Photographs in Annex. What is stated above is not written in the RO Banja Luka inspectors' reports or in the monitors' reports from the site.

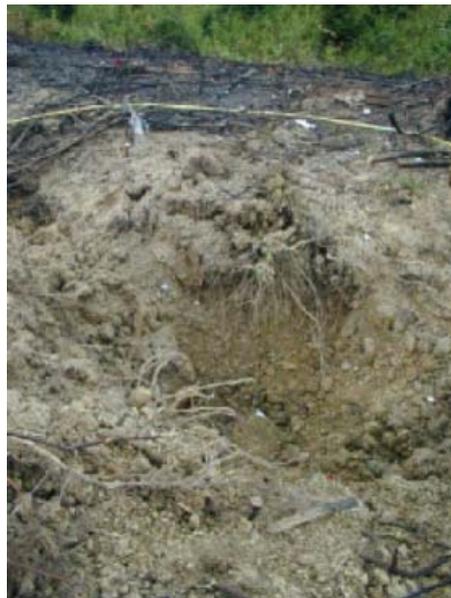
[The picture above shows the blast crater during the Accident Investigation.]

30. Crater is 2 metres in diameter and 1m into the depth. The bottom of the crater was very easy for the prodder to come through with all its working part (even to 25 cm into the depth). According to the information gathered on the site, Bol presume that the mine was 1 – 1.2 metres from the surface of the ground. Trenches that are connected with the accident site are as with the day of the investigation 30-40 cm deep. That leads the Bol to the presumption

that the mine was laid 60-70 cm from the surface. A possible position of the mine and the exact appearance of the crater found by the Bol are attached in annex. [Not made available.]

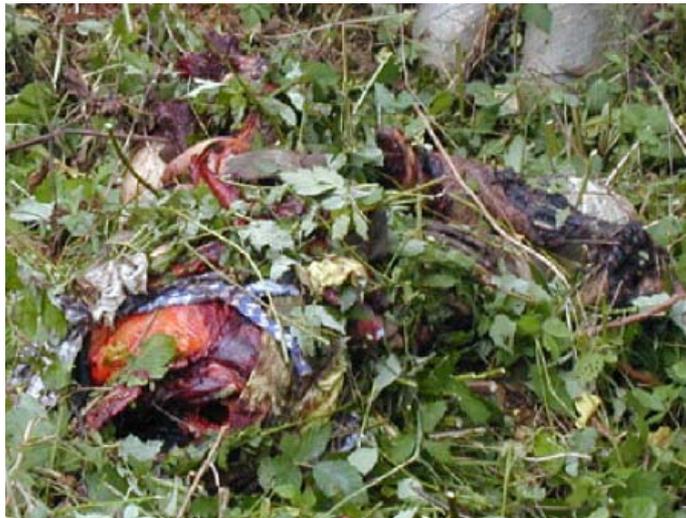
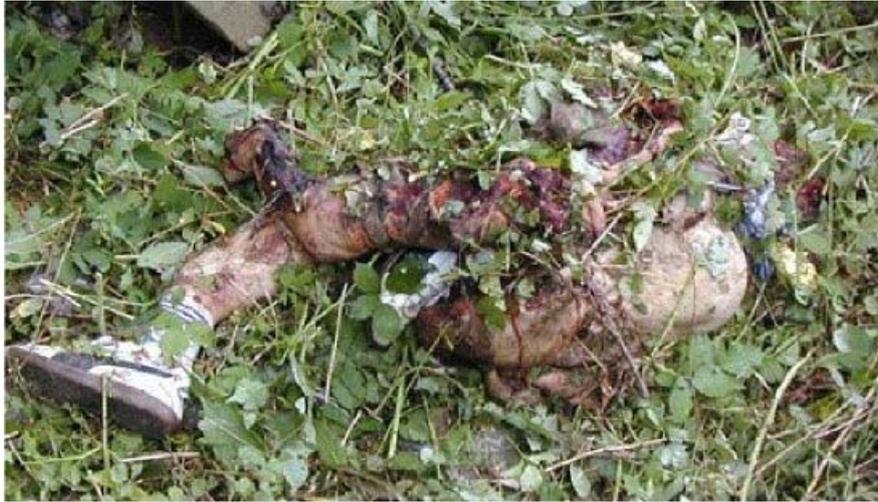
The pictures show Victim No.2 as he was discovered at the site.
