DDAS Accident Report

Report date: 19/05/2006	Accident number: 346
Accident time: 13:25	Accident Date: 09/03/2000
Where it occurred: Kopanice village, Nr Vidovice	Country: Bosnia Herzegovina
Primary cause: Field control inadequacy (?)	Secondary cause: Inadequate training (?)
Class: Missed-mine accident	Date of main report: 13/03/2000
ID original source: 1002 RB/NK/MM/VMM	Name of source: BiH MAC
Organisation: Name removed	
Mine/device: PROM-1 AP Bfrag	Ground condition: bushes/scrub grass/grazing area sparse trees
Date record created: 21/02/2004	Date last modified: 21/02/2004
No of victims: 1	No of documents: 1

The following is the MAC's Accident report, edited for anonymity.

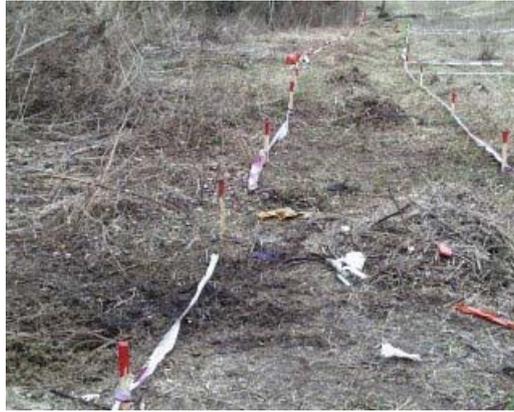
[The picture above shows the accident site before the investigator's arrived – it was taken by the police.]

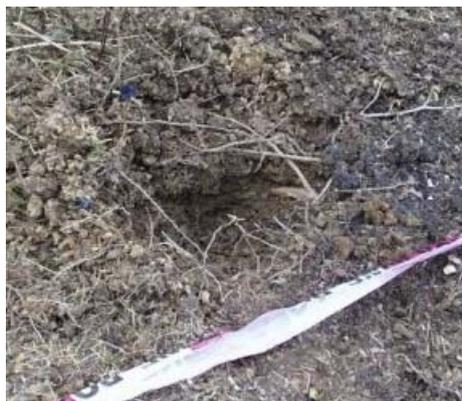
Accident spot (the imprint of the PROM mine plate) is 45 cms outside of the task, 19,15 metres from the edge of the top of the bank. The border of the task is marked with sticks while the tape is set after the accident.

[The picture above shows the crater and the distance from the "safe" area with the new tape placed before the investigator's arrived.]

Deminer had activated the mine by stepping on it (pressure) in the suspect area (plate imprint is 45 cm away from the tape connected to two stakes that are damaged by shrapnel.) The tape at the accident spot was attached to the stakes afterwards, additionally marking cleared and suspect area that is not within the task (the tape is not damaged by shrapnel).

The very place of the accident was disturbed and additionally marked. As stated before, the tape is not damaged by shrapnel, which can easily be seen from the photographs police have made. Lots of pieces of red tape were found near the place of the accident (used by [Demining group] in August 1999), though the bunch of the old red tape was found 31 metres away from the place of the accident.

It is stated in BH Standard that the place of the accident is to be closed and not to be touched in order to wait for the Board of Inquiry. It has to be the same as it was in the moment when the accident happened.

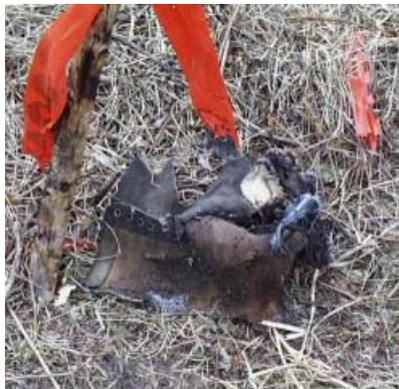
[The picture above shows one of the Victim's boots and scraps of marking tape.]

As stated by injured deminer as well as noticed at the spot (a bunch of old red tape 31 metre away from the accident, used in August 1999 by [the same Demining group] for marking cleared area) Board had concluded that the deminer was rolling the old tape. (Annex C – pieces of old red tape). The tape was most likely been cut near the accident spot. Deminer probably reached for the other part of the cut tape that was in the suspect area. Thus he himself stepped into the suspect area and activated a mine. There was no working lane in the vicinity in which demining was done at the moment.
