DDAS Accident Report

Accident details

Report date: 19/05/2006	Accident number: 347
Accident time: 08:55	Accident Date: 18/08/1999
Where it occurred: Stup II, Azici, Sarajevo	Country: Bosnia Herzegovina
Primary cause: Field control inadequacy (?)	Secondary cause: Management/control inadequacy (?)
Class: Detection accident	Date of main report: 25/08/1999
ID original source: RB/NH/IG/SD	Name of source: BiH MAC
Organisation: Name removed	
Mine/device: PROM-1 AP Bfrag	Ground condition: building rubble dry/dusty hard metal scrap residential/urban
Date record created: 21/02/2004	Date last modified: 21/02/2004
No of victims: 1	No of documents: 1

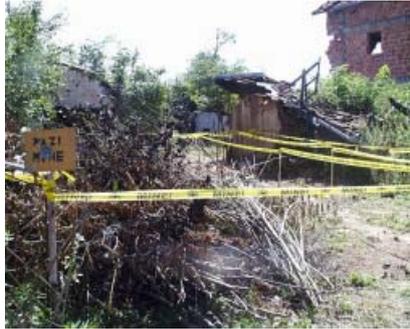
9. The accident occurred some 16 metres from the access lane, between two devastated houses. The area between houses is very hard to demine since the density of the vegetation, large quantities of metal and other debris. The site is located at BQ 838582, map sheet M1002, series 525-2. The assessment of the mine threat map (1:10000) and the sketch of the site and the accident site are attached in Annex C.
10. The site is accessible from the tarmac road and is located in the urban area of Azici. The site is located in the vicinity of an industrial and the houses already inhabited by the returnees.

[The picture above shows the accident area.]

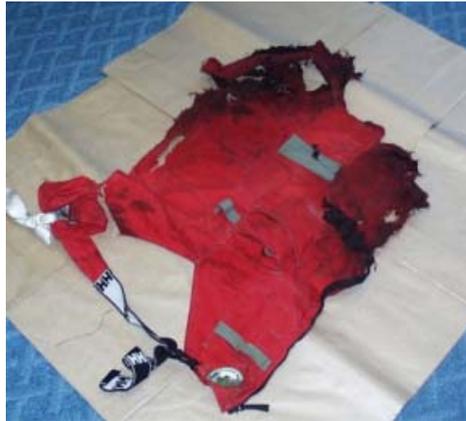
[The Victim's overall is shown above. It is upside down, so most damage occurred at the top of the legs, where it was shredded.]

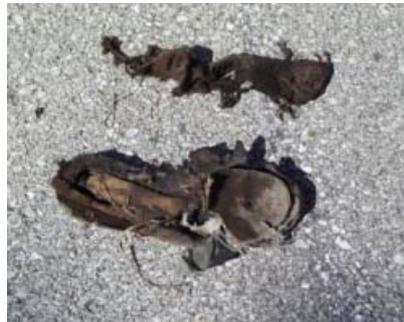
[The remains of one of the Victim's shoes is shown above, implying that he may have stepped on the mine and not detonated it with the detector head.]

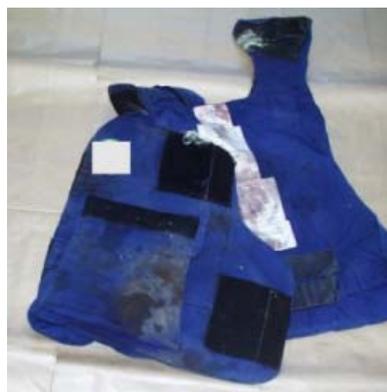
[The Victim's frag-vest is shown below. Fluffs of its Kevlar inner imply some penetrations.]

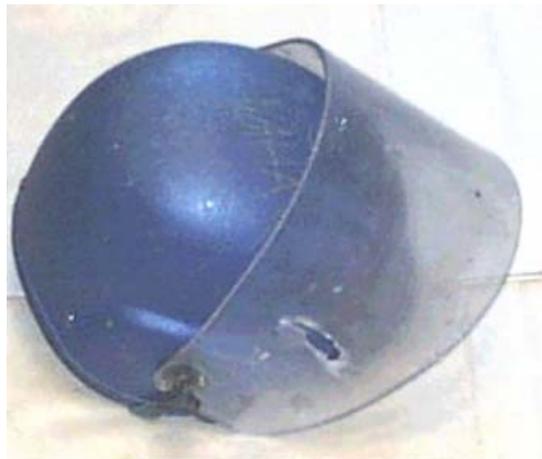
[The victim's helmet and visor (holed) is shown below.]

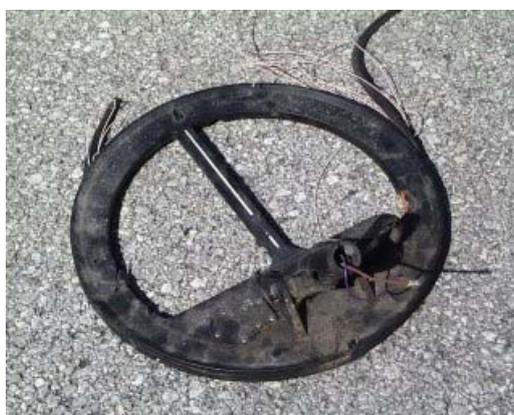
[The head of the victim's detector is shown above.]

36. Damages to the equipment helped in finding out the position of the deminer in the very moment of the accident.

50. Deminer had to enter with the MD's head between the turfs in order to sweep the area at the same height, with detector's head slanted. That was the only way to precisely locate the source of its signal, so he could have easily activated the fuse prongs of the PROM-1.

51. This assumption can be approved by the nature of the damages to the metal detector that was found near the working lane (Sketch at Annex C shows the places where pieces of MD were found, while the photographs at Annex G show the degree of damages to the

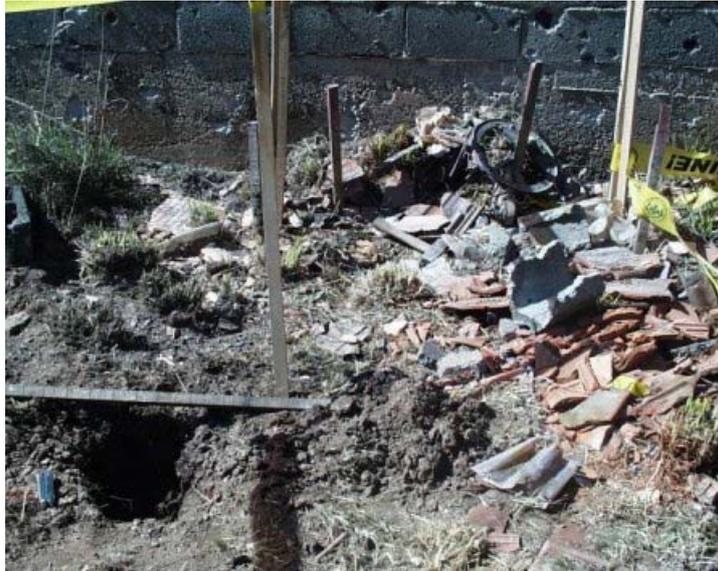
38. The PROM-1 detonated 20 (twenty) cms above the surface. (Easily spotted shrapnel in the wall of the nearby house. Photograph attached as Annex D.) [Not made available.]

[The picture shows the blast crater on the left, rubbish on the right.]
