DDAS Accident Report

Accident details

Report date: 19/05/2006	Accident number: 350
Accident time: 08:45	Accident Date: 15/07/1999
Where it occurred: Kratine, Gola Kosa village, Near Vitez	Country: Bosnia Herzegovina
Primary cause: Unavoidable (?)	Secondary cause: Inadequate training (?)
Class: Handling accident	Date of main report: 22/07/1999
ID original source: EB/RB/VM	Name of source: BiH MAC
Organisation: Name removed	
Mine/device: Fuze	Ground condition: agricultural (abandoned) bushes/scrub soft trees
Date record created: 21/02/2004	Date last modified: 21/02/2004
No of victims: 1	No of documents: 1

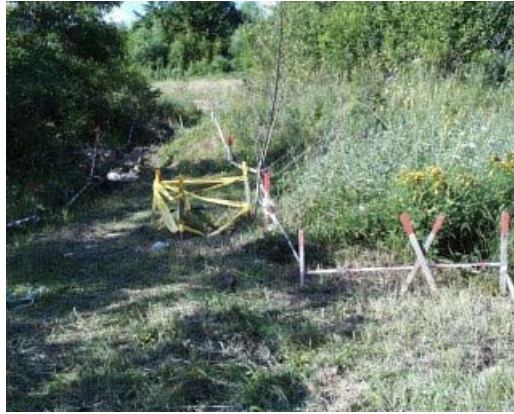
[The photograph above shows the area being cleared.]

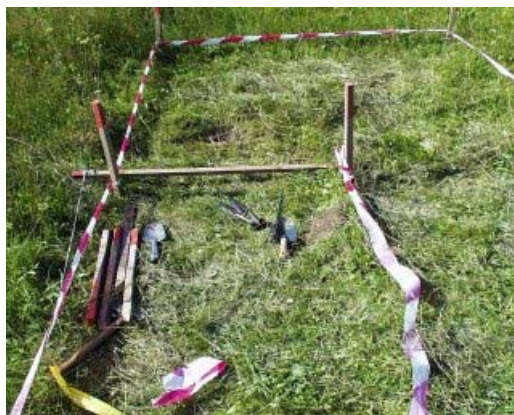
a) The accident site is some 40 metres from the track in a sparsely vegetated field

[The accident site is shown above. It is not obvious how the vegetation was cut so far ahead of the base stick.]

39) The injured deminer states that he detected the item first by metal detector, and then, using the prodder in his right hand, located a plastic item that he picked up with his left hand. It was initially assumed that the deminer had attempted to excavate the area on finding a suspicious item, as there was a large excavation, but this is not what the deminer stated. After completing the initial investigation the investigation team was concerned, as it appeared that the accident site may have been interfered with. The site, as shown in the photographs, had a crater measuring 20cm by 10cm by 4 cm deep (see Annex G) [not made available]. As the deminer and No 2 had both stated that no excavation work was conducted there should not have been a crater of this size.

41) The detonator has the equivalent power of a Number Eight detonator and therefore if the detonator exploded in the ground or at ground level the impact would be limited. If the fuse had detonated in the ground the resulting hole would be small, no larger than a few centimetres in radius. The investigation team took five (5) electric detonators to the site on the 20 July and in similar weather conditions and at the same time of day as the accident detonated them in various positions to simulate the fuze explosion (see details at Annex H). The results clearly illustrate that the accident site crater was considerably larger than the trial detonator holes. As considerable explosive force would have been absorbed by the hand of the deminer it is reasonable to expect that the crater would be the same size or smaller than the trial detonations.

a After an accident the site should immediately be closed and no person should approach the accident site until requested to do so by the investigation team or until the site has been cleared by the accident investigation team.
