DDAS Accident Report

Report date: 19/05/2006	Accident number: 352
Accident time: 12:50	Accident Date: 05/08/1999
Where it occurred: Nr Vidovic village	Country: Bosnia Herzegovina
Primary cause: Management/control inadequacy (?)	Secondary cause: Field control inadequacy (?)
Class: Detection accident	Date of main report: 11/08/1999
ID original source: EB/NH/DG/SD	Name of source: BiH MAC
Organisation: Name removed	
Mine/device: PROM-1 AP Bfrag	Ground condition: agricultural (abandoned) bushes/scrub grass/grazing area
Date record created: 21/02/2004	Date last modified: 21/02/2004
No of victims: 1	No of documents: 1

The following is the MAC's Accident report, edited for anonymity.

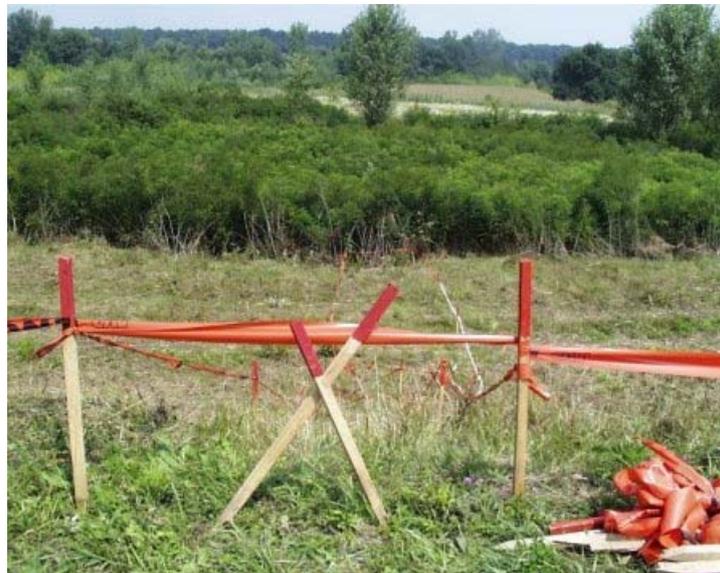
[The picture above shows the start of the accident lane and the vegetation being cleared.]
