DDAS Accident Report

A Board of Inquiry (1301) 03/01 2001 was convened as a result of a mine strike on a Hydrema flail being operated by [two NGO's together] on 29 Sep 01 in Shilalo minefield ER246.

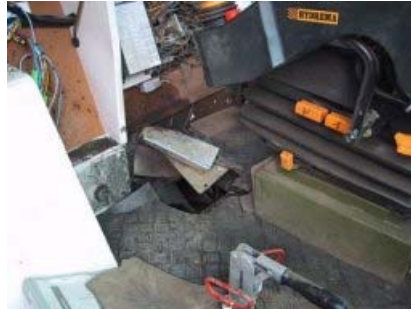
2. Protection to the operator was inadequate as shown by the blast penetration of the cab.
3. The vehicle needs strengthening in key places, primarily on the floor and door locks
4. The machine was determined to have passed only once over the ground where flailed and on the site the deepest penetration achieved by the flail was found to be only 100mm (4").
5. Should the vehicle have performed to the manufacturer's claimed standards or at least the national standards, the mine would have been destroyed by the flailing action and if it had missed the mine there should have been no injuries to the operator as a result of blast directly under the vehicle cab.

The picture above shows the floor of the cab where the steel plate covering the pedal-stem hole has lifted.

12. Unexpected damage to the vehicle included the relocation of the protective plate under the cabin, and loosening of the covering plate under the pedals inside the cabin. (It should be noted that no such damages were incurred during a previous worst case acceptance test, detonating 10 kg TNT under a corresponding wheel).

13. Injuries sustained by the driver included bruises, caused i.a. by loose objects in the cabin, and a broken heel, caused by the upward movement of the covering plate under the pedals.
