# DDAS Accident Report

<b>Report date:</b> 02/07/2014	<b>Accident number:</b> 368
<b>Accident time:</b> 10:30	<b>Accident Date:</b> 18/03/1993
<b>Where it occurred:</b> Chana Pale, Xangongo, Cunene Province	<b>Country:</b> Angola
<b>Primary cause:</b> Inadequate equipment (?)	<b>Secondary cause:</b> Field control inadequacy (?)
<b>Class:</b> Missed-mine accident	<b>Date of main report:</b> [None]
<b>ID original source:</b> HE/HGK	<b>Name of source:</b> HE/HGK/Others
<b>Organisation:</b> [Name removed]	
<b>Mine/device:</b> TM57 AT blast	<b>Ground condition:</b> agricultural (abandoned)  bushes/scrub  sparse trees  wet
<b>Date record created:</b> 21/02/2004	<b>Date last modified:</b> 02/07/2014
<b>No of victims:</b> 1	<b>No of documents:</b> 1

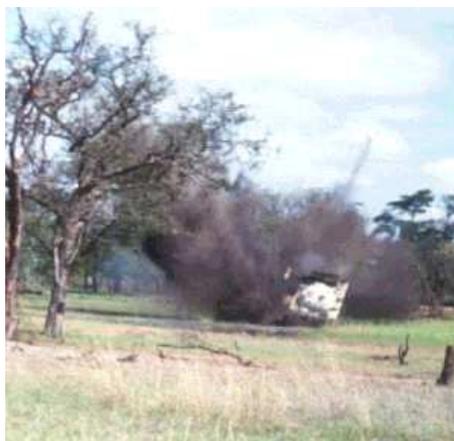
The tank continued forwards for a few seconds through approximately 20cm depth of mud with its underside in contact with the ground or shallow water. A mine was initiated underneath the middle of the inner side of the left track of the tank, a position which implies that the mine may have been already under the track when [Victim No.1] boarded the tank. The rotating base-plate, without the support of the gun, flipped up inside the tank. The round, rotating-disk base-plate was more than a metre in diameter and about 15mm thick steel. There was a 60cm long and 10cm wide breach in the armour parallel to the left track. The second to last wheel on that side was blown 50m away. The tank and roller system (weighing 35 tons) was lifted high into the air.

The picture below shows the tank standing almost on end when the detonation occurred. Captured on slide-media, it is very poorly detailed.

The blast breaching the hull caused [Victim No.1]' internal pressure injuries. The unsecured plate in the base of the tank was distorted and lifted in a way that broke his legs.

The area around and beneath the tank should be cleared manually. This will involve moving the tank to a cleared area. The area cleared should be properly recorded and that record passed to the Angolan National Authorities so that further confusion over what has been done in the area can be avoided.
