# DDAS Accident Report

## Accident details

REPORT FOR ACCIDENT INVESTIGATION BOARD OF INQUIRY – No 015/2001

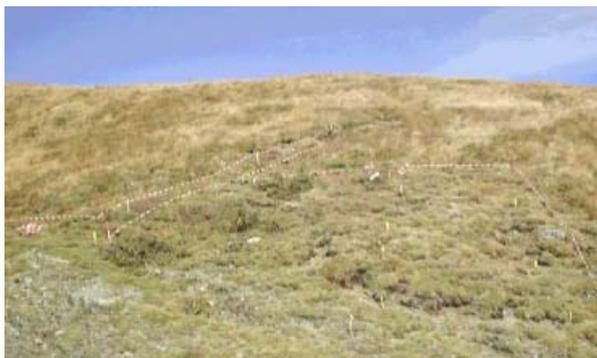
8) It is a possible that the angle of the prodder when the Victim was investigating the detector reading was not at 30 degrees. Given that he was prodding up hill into a slope in the kneeling position meant that the angle of his prodder to the ground would have more likely been at an angle greater than 30 degrees and probably nearer 90 degrees. Another possibility is that mine may have been face onto him and therefore detonated when he prodded into it.

The picture above shows the accident site on a hillside.

It is highly likely that given the steepness of the slope the Victim was working on, the angle of the prodder would have been greater than 30 degrees to the ground. It is the view of the board that this was the major contributing cause of the uncontrolled detonation.

The Demining group amend their SOPs to state that when conducting prodding on a slope, all deminers must carry this out in the prone position, and ensure that the angle of the prodder remains at 30 degrees to the ground at all times.

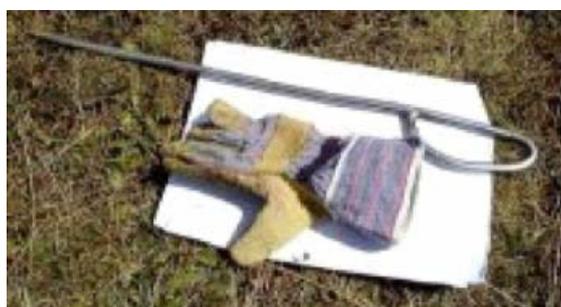
The picture below shows the victim's right glove and prodder.

There is no damage to the prodder or to the right glove. The Victim did not suffer any injuries to his hands.

22) The Victim was investigating a reading from his metal detector with his prodder at the time of detonation. There was no damage to either his detector or prodder.

The fact that the deminer’s prodding tool, glove and hand were not damaged in the blast imply that they were not directly over the mine as they would have been if he was prodding too steeply.
