DDAS Accident Report

Report date: 15/03/2004	Accident number: 371
Accident time: 10:55	Accident Date: 06/04/2001
Where it occurred: Grebnik, S.E. Klina	Country: Kosovo
Primary cause: Field control inadequacy (?)	Secondary cause: Other (?)
Class: Excavation accident	Date of main report: 18/04/2001
ID original source: MF/LL/AH/JF No.001/2001	Name of source: KMACC
Organisation: Name removed	
Mine/device: BLU-97 submunition	Ground condition: agricultural (recent) grass/grazing area soft trees
Date record created: 21/02/2004	Date last modified: 21/02/2004
No of victims: 2	No of documents: 2

Accident report

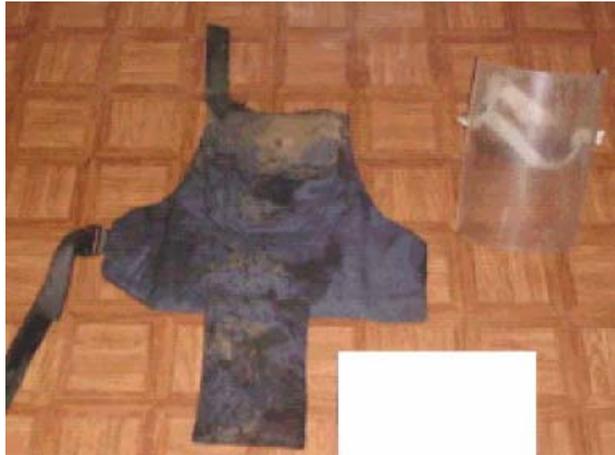
26) At the time of the accident both BAC deminers were wearing protective jackets, it is not known, nor is it possible at this time to conclude whether the BAC deminers were wearing their visors. This however has no bearing on the investigation, as the break had been called and in accordance with [Demining group] SOPs, visors can then be removed.

[Photographs showed damaged armour but visors undamaged, therefore not worn.]

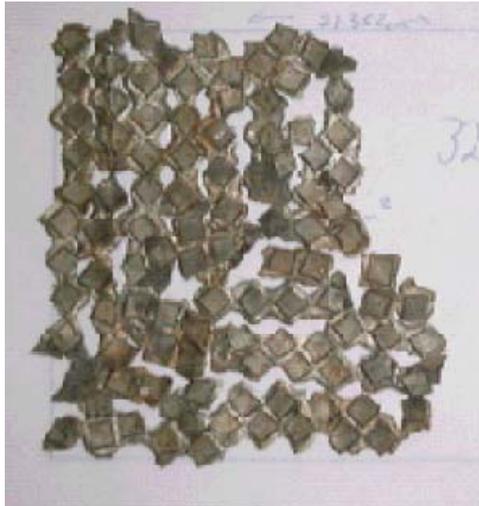
[The picture below shows recovered fragments from the crater.]

- There was a sub-surface detonation of a BLU-97 sub-munition. Evidence shows that the crater had heavy blackening to the sides, was of a bulbous shape with fragmentation lining the sides. Also a camouflet had formed 360 degrees around the edges, with the debris on the North Western side spread farther out than on the other sides (direction of the plasma jet). The crater size was 70 cm in diameter and 45cm at the deepest point. This is considerably larger than a crater that would be formed by a surface detonation of a BLU-97 sub-munition.

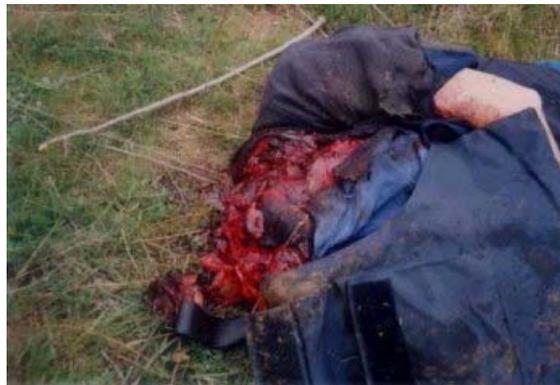
- The plasma jet of the BLU-97 sub-munition decapitated and subsequently killed [Victim No.1] as it moved out from the seat of detonation in a North Westerly direction. It was also the concentrated directional blast effect from the plasma jet that lifted his body and carried it the distance of 12m, to the North West location where it was later found.

The photograph below shows destruction of Victim No.1's head. Others showed severe hand and arm injuries.
