DDAS Accident Report

REPORT FOR ACCIDENT INVESTIGATION BOARD OF INQUIRY – No 016/2001

Mine Accident that occurred in MNB West on Sunday 30 September 2001.

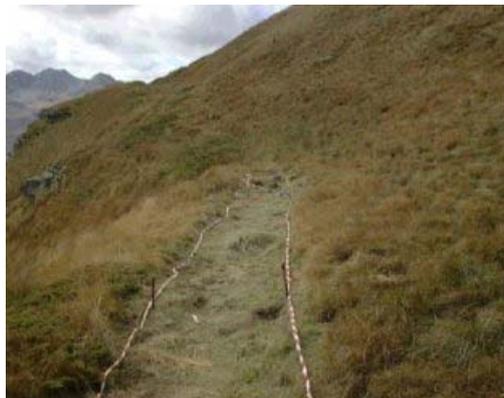
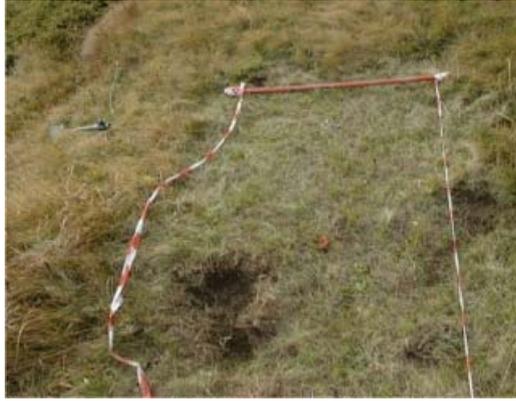
9) The MACC QA Officer along with [the Demining group's] Programme Manager (ITF Contract) [name excised] commenced the investigation the following day. The accident site had been left untouched since the time of the accident. The blast hole was approximately 1.5m before the base stick in the cleared lane. The metal detector was severely damaged in the blast. The search head had been detached from the shaft and control box as a result of the explosion. Deminer A had left the detector next to the left side mine tape of the clearance lane when he returned to the rest area. The detector was beside [the Victim's] left knee as he knelt and was therefore caught in the blast.

10) The shape of the blast hole is not consistent with a single PMA3 explosion. Deminer A has stated that he did not conduct any excavation in the vicinity of the mine that [the Victim] knelt on. There is a possibility that there may have been two mines involved in the blast due to the shape and size of the hole. The depth of the blast hole was not indicative of a deeply laid mine.

Views of the accident site and blast crater are reproduced below. The site is within 25 metres of the accident that occurred on 25th September 2001.

[The lane marking does not include the use of regular stakes/posts and so its precise location can be moved by wind.]

The Victim was in the process of getting into the prone position in order to remove the PMA3 located by Deminer A when he knelt on the another PMA3 in the cleared lane. This mine was not located and was therefore missed by Deminer A. The Vallon Metal Detector was next to the mine marking tape to the left of the lane. From the explosion the shaft was shattered and the detector was in two pieces with the control box part way down the hill and the search head in the lane.

Although the investigator did not identify it as a cause, the photographs he took during the investigation show that lane marking was potentially imprecise and used a method that would not have been acceptable to many demining groups, and is not as recommended in the IMAS.
