DDAS Accident Report

REPORT FOR ACCIDENT INVESTIGATION BOARD OF INQUIRY – No 010/2001

Mine Accident that occurred in MNB West on the 31st July 2001

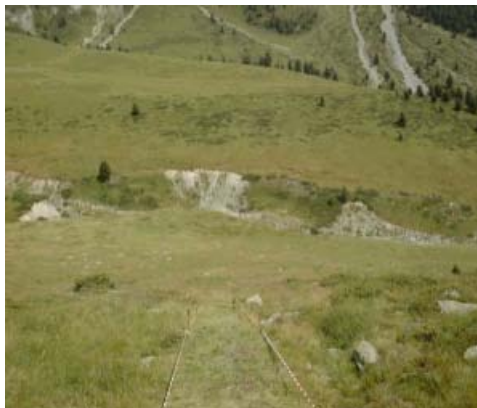
[The picture above shows the safe lane leading to the gully where the accident occurred.]

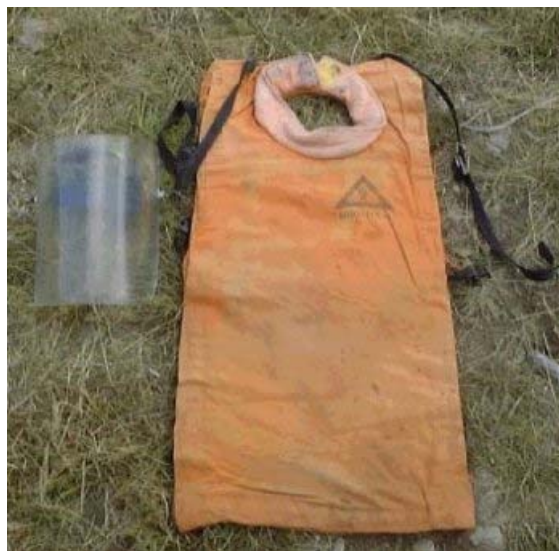
21) At the time of the accident all personnel working in the mined area were wearing PPE. Following the accident all items of PPE were removed and cleaned by [the Demining group]'s personnel. On inspection of the PPE the following day, the only damage sustained was to the left hand glove.

The victim's PPE is shown above.

The body armour apron used by the demining group is made of ballistic aramid and has a NATO STANAG V50 rating of 380 m/s (as opposed to the 450 m/s recommended in the IMAS). The lower rating and the more flexible material have proven effective against blast mines in more than 25 excavation accidents listed in this database.

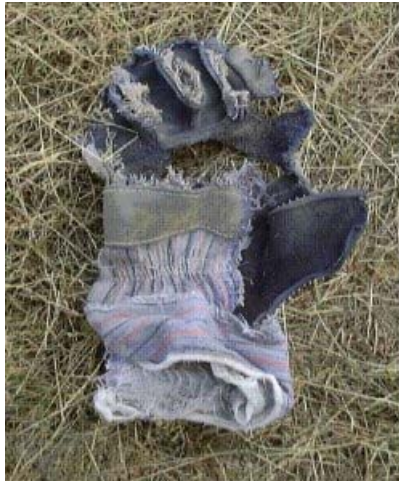
The victim's left glove is shown above.

Note the fact that the gardening glove provided no protection to his left hand. If the deminer was right handed, the left hand would have been guiding the probe and would have been far closer to the detonation than the right hand. This may be especially true when trying to move rocks with a probe. There is no record of which hand the deminer favoured.
