DDAS Accident Report

Report date: 19/05/2006	Accident number: 384
Accident time: 13:20	Accident Date: 18/04/2002
Where it occurred: Kareza village, Mawat, Sharbazhier, Suleimanyah governorate	Country: Iraq
Primary cause: Unavoidable (?)	Secondary cause: Inadequate equipment (?)
Class: Excavation accident	Date of main report: 18/09/2002
ID original source: NPA/MAP/Adm/04-02	Name of source: ET:NPA
Organisation: Name removed	
Mine/device: Type 72 AP blast	Ground condition: grass/grazing area metal fragments
Date record created: 22/02/2004	Date last modified: 29/02/2004
No of victims: 1	No of documents: 1

A summarised internal demining NGO report was made available in 2002. It is reproduced below, edited for anonymity.

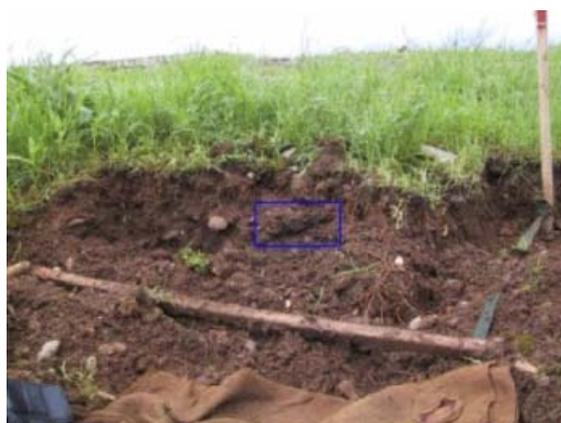
[The picture above shows the site of the accident.]

The lane starts with a slope to plane ground. Green grass, approx 25cm high, covered surface. The ground was wet due to the rain in the day before. All marking system and the clearance tapes were used correctly.

Only black mud and some small plastic pieces of the casing could be found in the explosion pit.

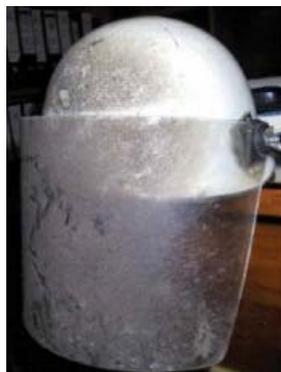
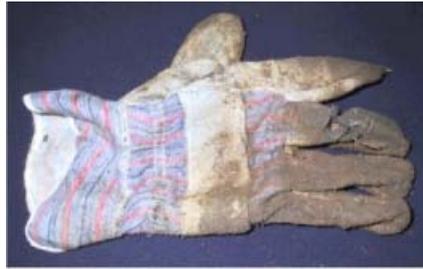
No penetration happened to the vest and the visor. The visor has very well protected the face and eyes.

The pictures below show the Victim's leather faced gardening glove and his helmet and visor.

The visor was perpendicular to the explosion pit. That didn't allow the pressure to lift up the visor and consequently the face and both eyes were kept safe.

Emphasis on wearing the safety equipment properly, visor in particular.

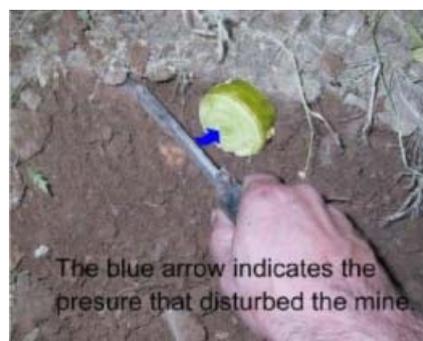
Using right hand and excavating from the left to right of the base stick, this would likely allow generating pressure to uncleared area.

The bayonet didn't hit the mine directly, it pushed the earth and the earth disturbed the mine.

Handling the bayonet was as illustrated.

1-2 days refreshment for all the deminers and the field leaders as to manual drill and tools applying in excavation.

Revising the drill with bayonet.
