DDAS Accident Report

Accident details

The accident involved the "Mine Clearance Cultivator", a machine owned by the US government and under trial with [a demining NGO] in Southern Angola.

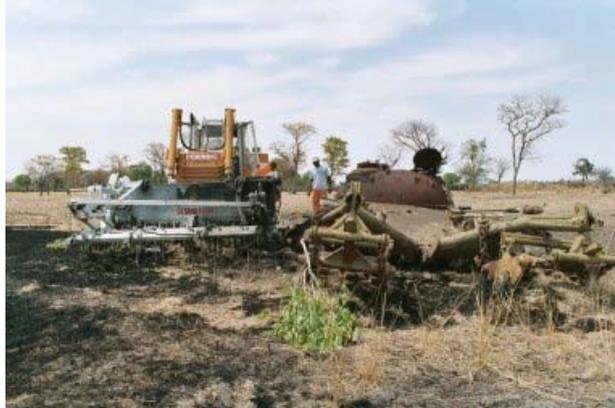
[The photograph above shows the MCC alongside the T55 tank after the accident.]

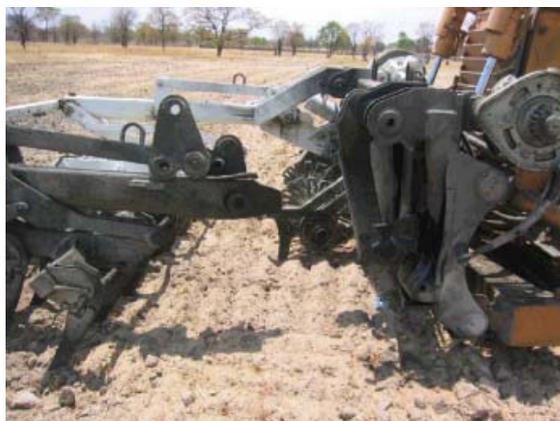
I found that the device had detonated on the left-hand side (facing forwards) of the MCC's cultivating attachment. It had apparently detonated above ground level and on top of the auger to the rear of the attachment, exploding as it passed to the side of the machine. Damage to that side of the auger and entire cultivating attachment was severe, with large parts separated. This means that the mine detonated on the T55 side of the MCC, and there was some evidence of sooting and light fragmentation damage to the side of the T55 tank. The tank was in poor condition and some damage may have been old. There was no evidence that either the tank or the MCC were physically lifted or moved sideways by the detonation.

The rear window of the MCC cab had sprung inward (unbroken) and the control panels come loose. There was also some damage to the cab structure, with one door jammed and another twisted. The glass inside the camera on that side was broken, although the cover (presumably polycarbonate) was not.

The left side of the cultivator attachment was wrecked as shown below (this picture was taken after the machine had been withdrawn from the suspect area).

The cultivating attachment is so severely damaged that it may not be economic to repair it.

I recommend that there would be little or no value in repairing/replacing the damaged cultivating attachment. However, it is possible that another attachment might make the machine more useful despite its gross weight (the bulldozer is so heavy that it cannot be driven over road bridges in the region).

If the MCC is to be repaired, I recommend that the repair should include the installation of a means of removing the vehicle from a suspect area after a blast without having to drive it manually. This may be achieved by fitting a properly armoured cab (so protecting the RC systems) and duplicating controls so that a secondary system can be switched on after a blast – one that is unaffected by the magnetic surge associated with the first large blast. Fitting an armoured cab would also reduce the risk involved in withdrawing the machine from a suspect area manually if this is required.

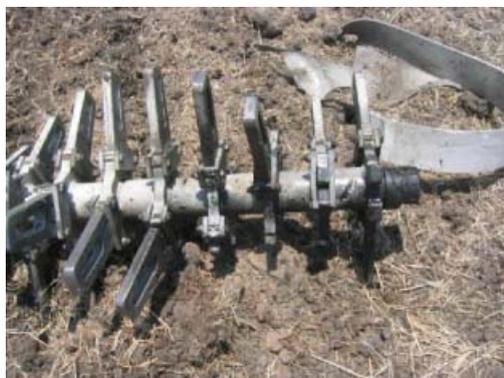
deminer then checked where the MCC had been standing and found further debris from the detonation. None of that debris was from the device involved in the accident. There was no crater, but there was evidence of a point of initiation with “teeth” broken from the auger driven into the ground - indicating that the device was above those teeth when it detonated. Damage to the auger’s drive-train on that side was catastrophic (all parts separated, including parts of the triple-width chain) which confirms where the detonation occurred.

The picture below show the auger damage.

Blast sooting on the cultivator backplate supported the inference about the place of detonation.

The mine appeared to have initiated as it left the auger and so below or beyond the left-side upper support arm of the cultivator and alongside the auger-drive mechanism. This means that the detonation was confined on one side by the cultivator and on the other by the wrecked T55 tank. The T55 is embedded in the ground and has not moved (crusted earth around the wheels and rollers was unbroken). Reflection from the tank may have had the effect of intensifying the blast damage to the cultivator and auger mechanism.
