DDAS Accident Report

REPORT FOR ACCIDENT INVESTIGATION BOARD OF INQUIRY – No001/2003

DEMINING Accident that occurred in Arnoun on 12th January 2003 in which a [demining group]

deminer [name excised] was injured.

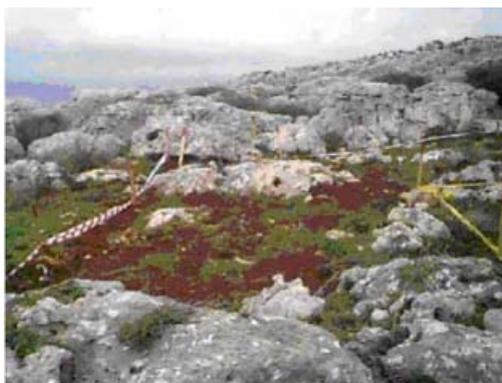
GENERAL VIEW OF THE AREA:

5. At the time of the accident [Demining group] Deminer [the Victim] was working in the first lane. The actual clearance lane was to the right hand side of the mine rows and due to the high level of metallic contamination in the ground the sapping method of clearance was being used.
6. From the start of the day's clearance activities (4 hrs 10 minutes had elapsed), [the Victim] had not located the mine. He then continued to extend the clearance lane approximately 1m whereupon he came across a rock to the left hand side of his lane marking rope. As the rock

would have been in the approximate location of the mine, he decided to clear around the rock. Prior to actually clearing around the rock, [the Victim] attempted to detect the mine with the detector, but due to the high level of metal contamination in the area he was unable to obtain an exact position of the mine.

7. [The Victim] then excavated around the front and right hand side of the rock using his right hand, nothing being located. As it would have been difficult to excavate around the left hand side of the rock using his right hand. Deminer [second inconsistent name] had moved his legs 15 cms in depth when there was an uncontrolled detonation, after he stepped on the mine.
